Study of the Shape of the Historic Skowl Arm Haida Canoe

By V. Jason Rucker and the Haida Canoe Revitalization Group, 2025.

The objective of this report is to explain the modeling and drawing of this canoe clearly enough for others to understand, and to allow them to judge where alternative assumptions or interpretations could be made.

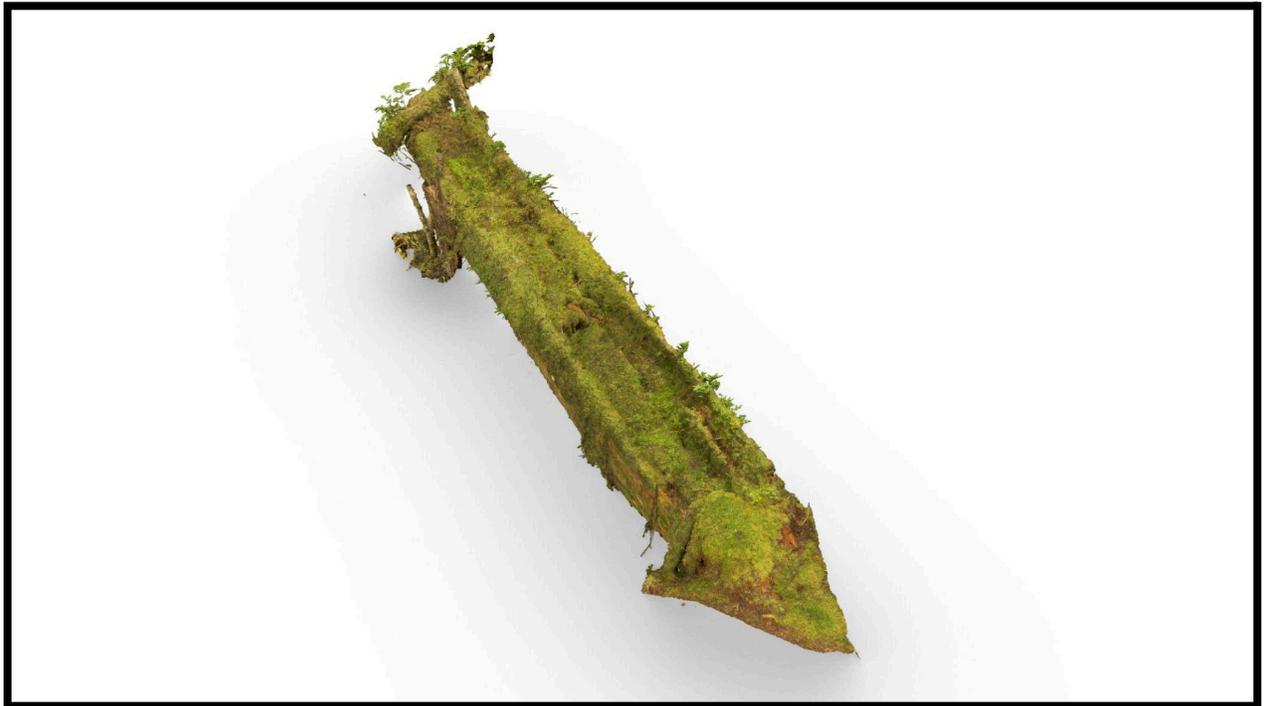
[Figure 1. Perspective view of canoe model. Stern is closer to viewer at the lower right.]

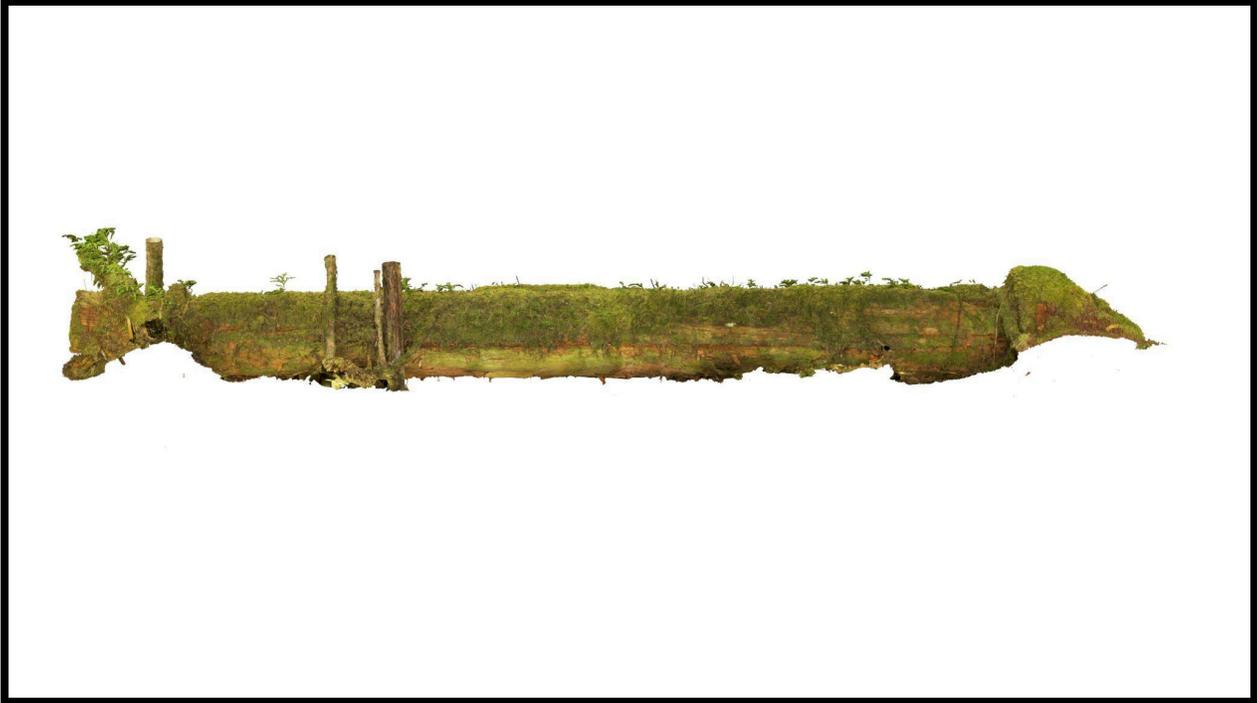
[Figure 2. Port side, profile view.]

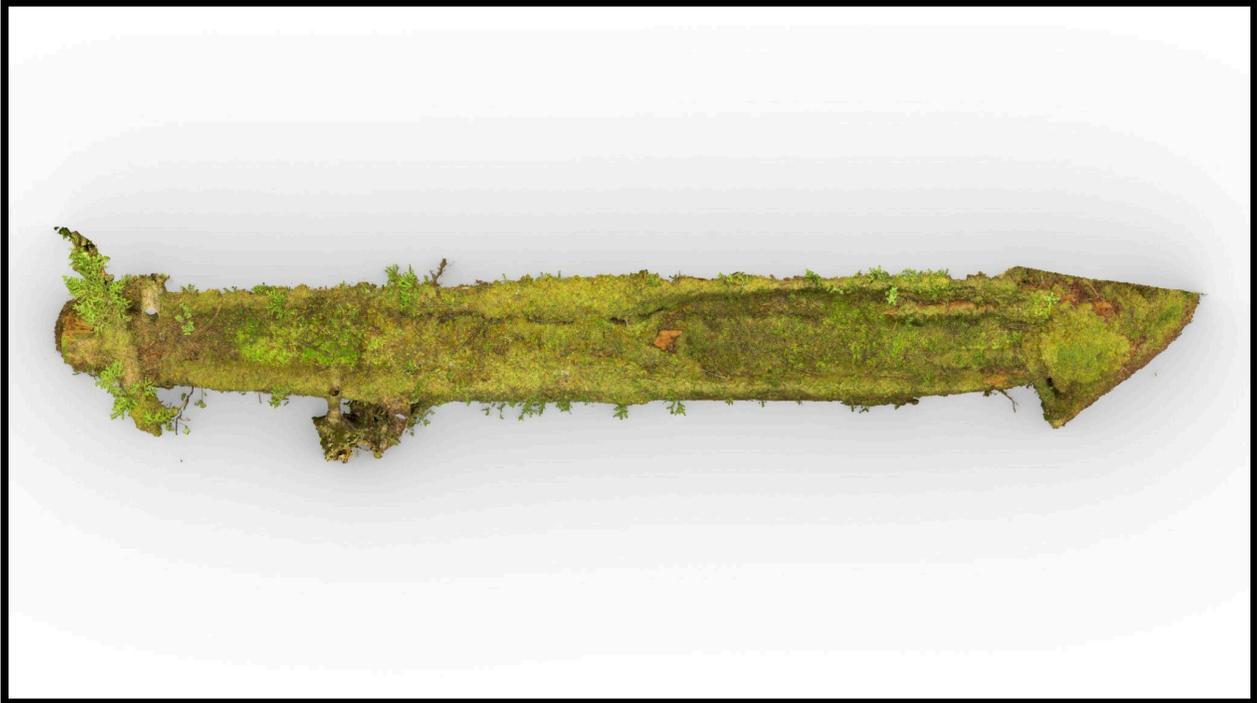
[Figure 3. Top or plan view.]

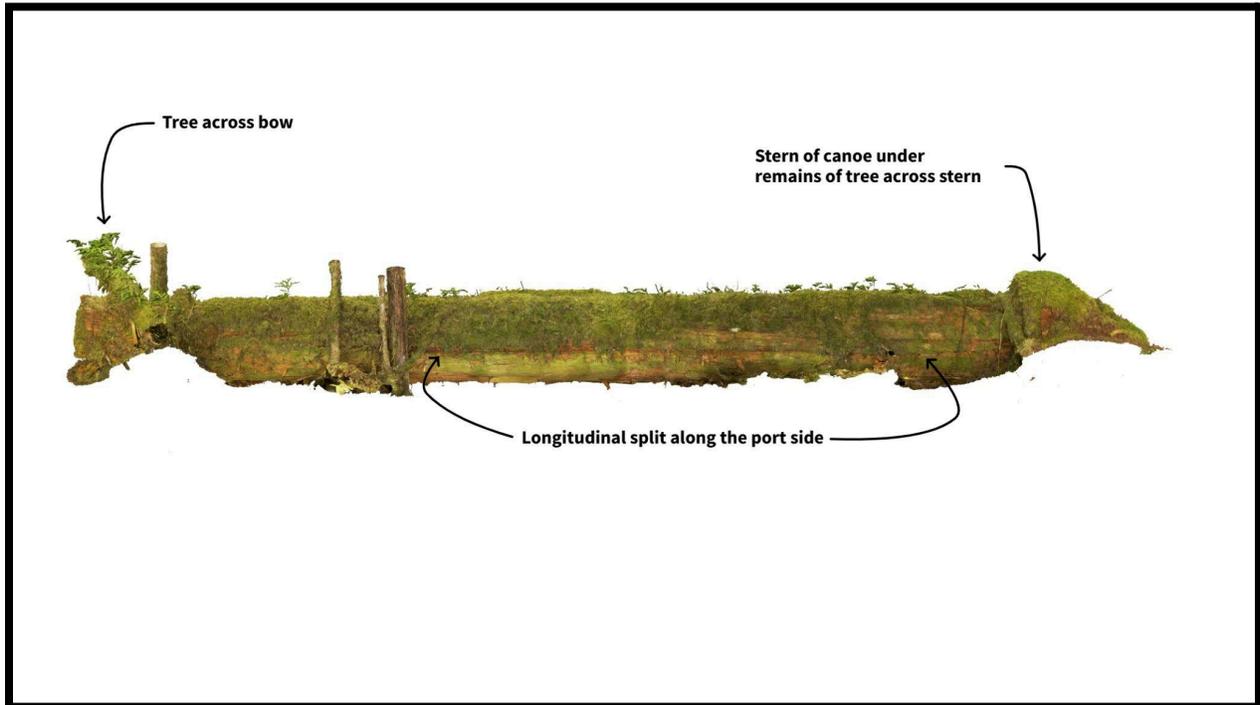
[Figure 4. Port side, profile view, showing damage.]

- i. Both ends of the canoe are broken and rotten. A small tree has fallen across the bow, accelerating its deterioration. It appears as if a larger tree has fallen across the stern, likewise accelerating its deterioration. The tree across the stern is badly deteriorated itself, moss covered and broken down, almost unrecognizable, suggesting it fell longer ago than the one at the bow which is intact.

- ii. The stern has collapsed aft of the tree that fell across it. In photos taken in 2011 a bit of the stern is still up off the ground. In 2024, the stern, aft of the fallen tree is on the ground covered in moss and difficult to recognize.

- iii. The bow is still intact and off the ground, but the tree across it and a tree growing against the starboard side has accelerated its deterioration.

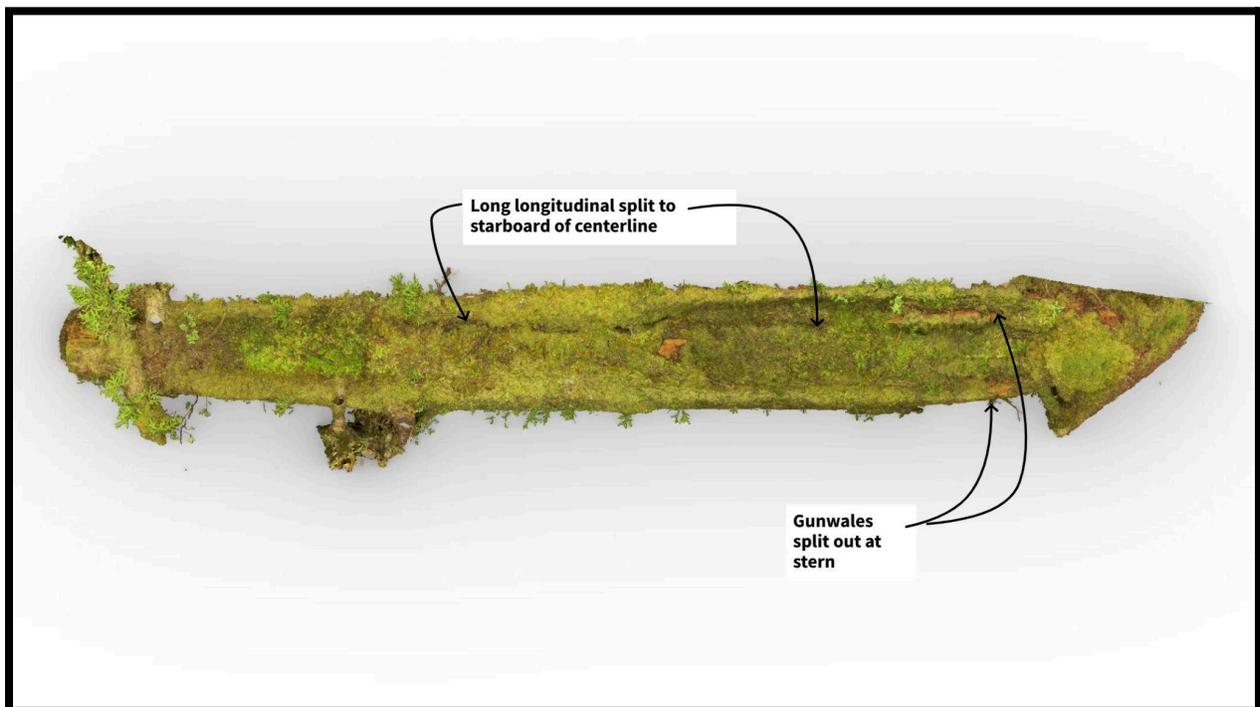
[Figure 5. Plan view, stern on the right side, showing damage.]

- iv. On both sides, aft, the upper edge (or gunwale) looks as if it has split and sprung out away from the center. The split-out gunwales are visible in plan view just forward of the tree that fell across the stern.

1. On the port side this split only affects the upper edge of the side of the canoe.
 2. On the starboard side the split is more significant. The split on the starboard side appears to continue vertically through the canoe. Much of the starboard side leans out away from the center of the canoe.

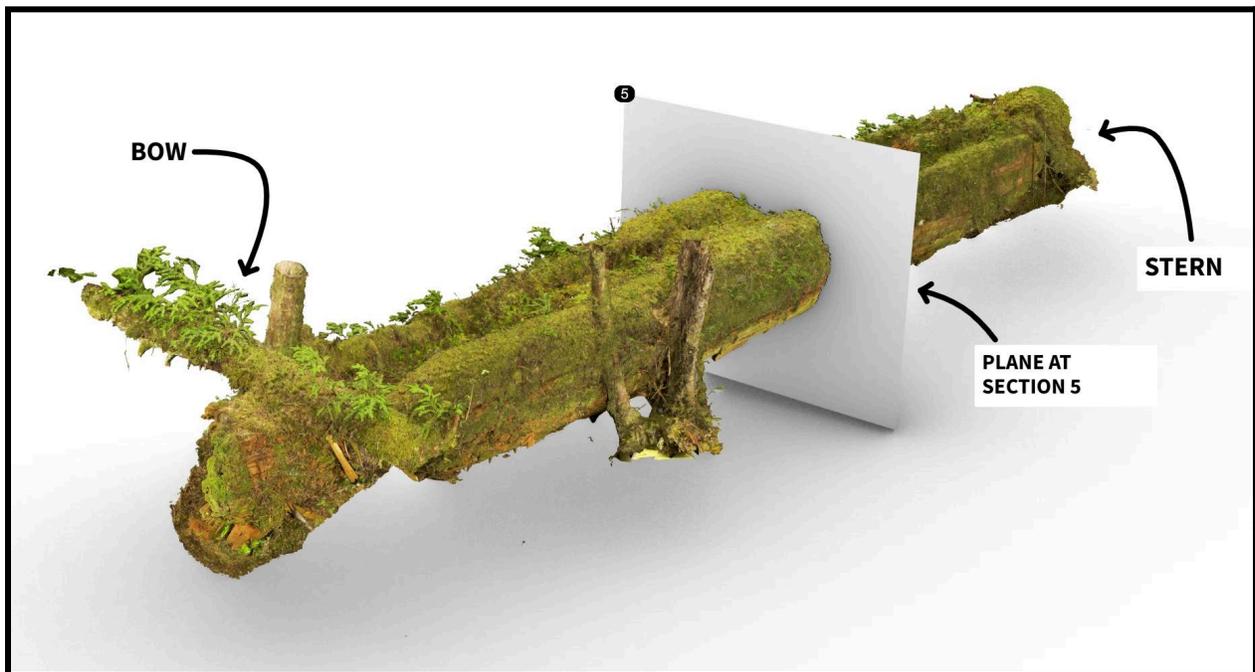
[Figure 6. View of port side of canoe, bow closer to viewer in lower left, showing plane at Section 5.]

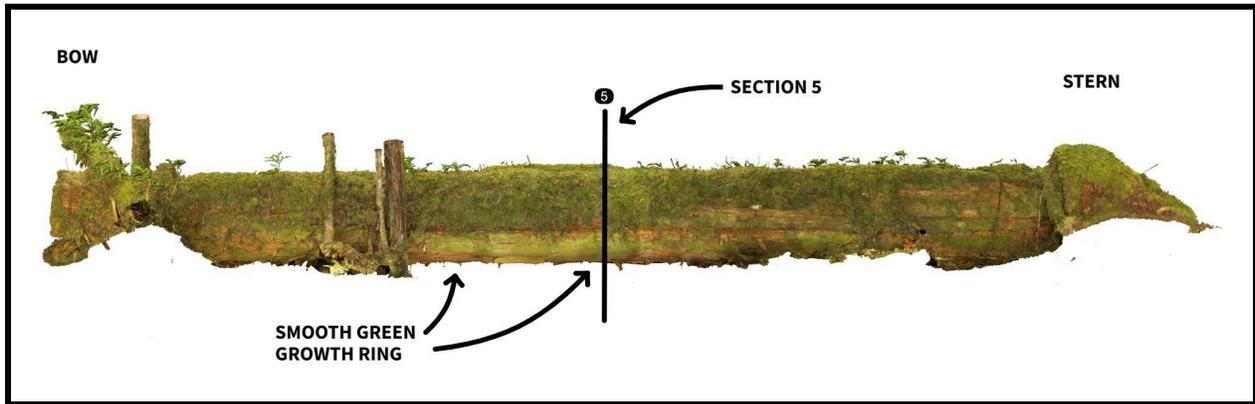
- i. When looking at the canoe or the model, the lower part of the port side is seen to be smooth and pale green. This pale green appears to be a single growth ring of the tree.

[Figure 7. Port side, profile view, showing Section 5 and smooth growth ring.]

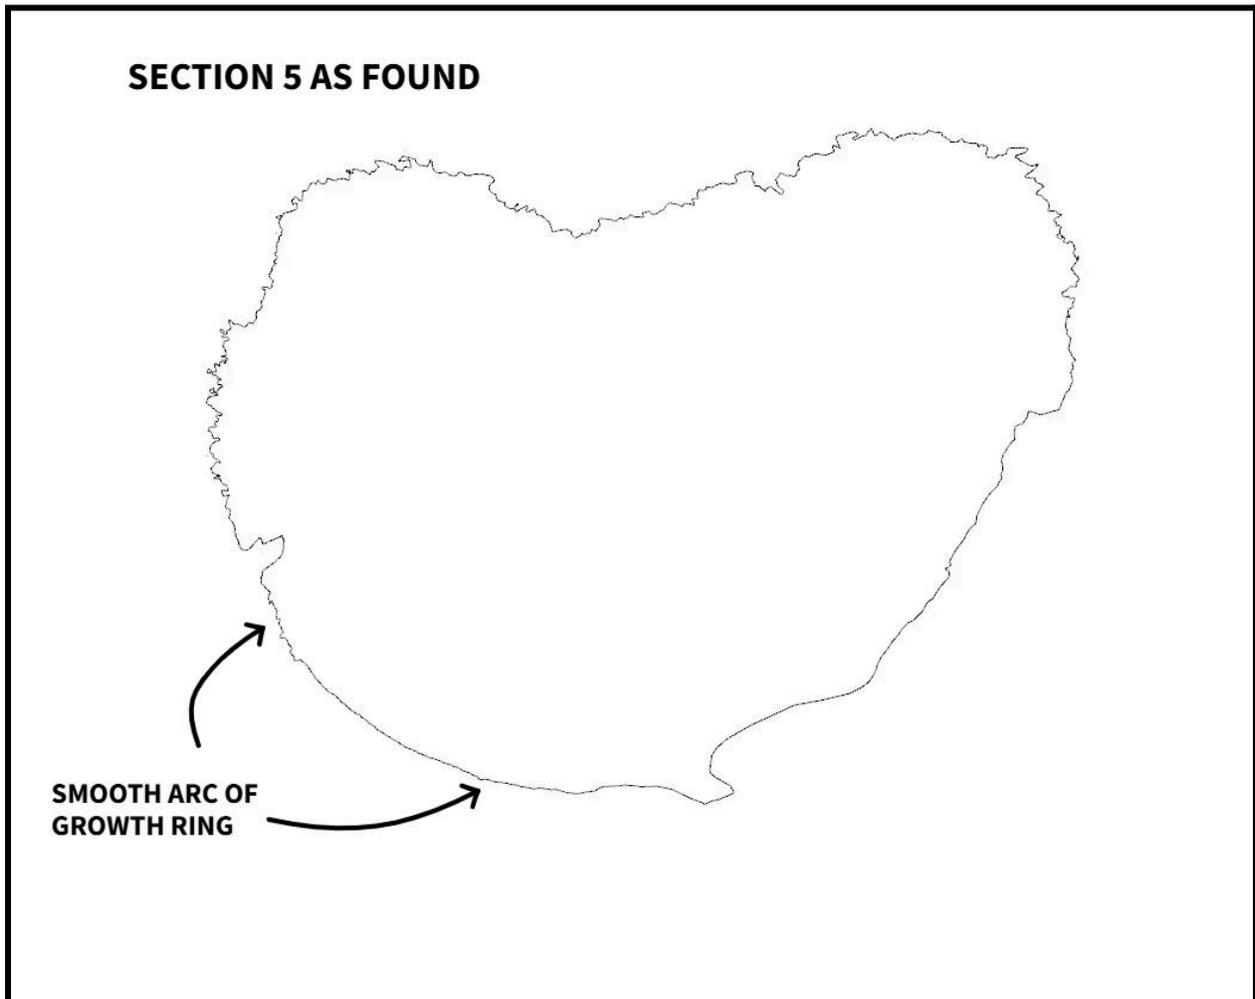
- ii. This smooth green growth ring shows up as a smooth arc on the lower port side in section 5 As Found

Figure 8. Section 5 As Found.]

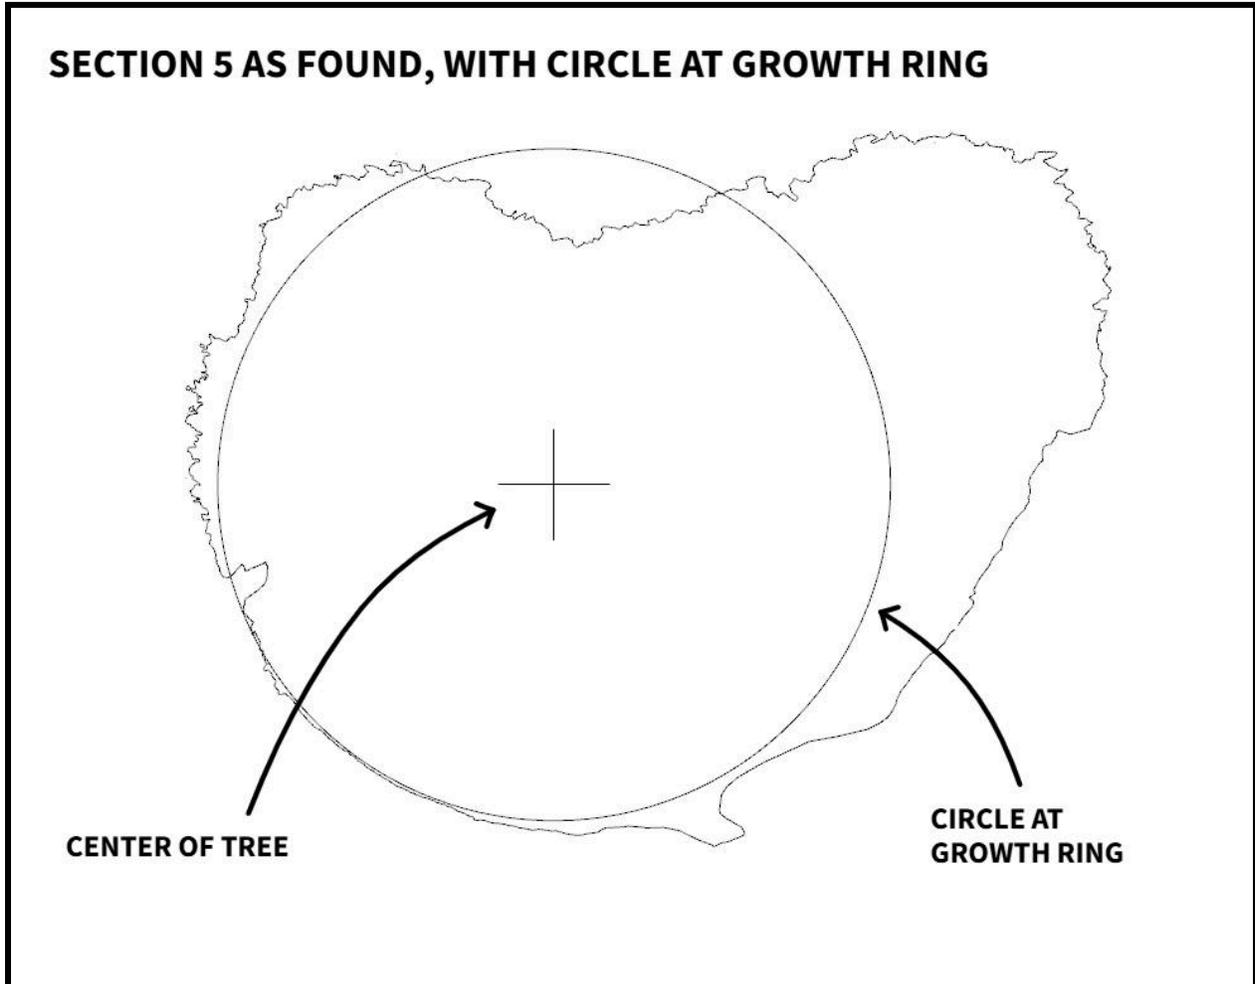
- iii. Extending the smooth arc of the growth ring in Section 5 produces a circle representing the entire growth ring of the tree. This circle then allows us to approximate the center of the tree at the center point of that circle.

[Figure 9. Section 5 As Found with circle at growth ring and center of tree.]

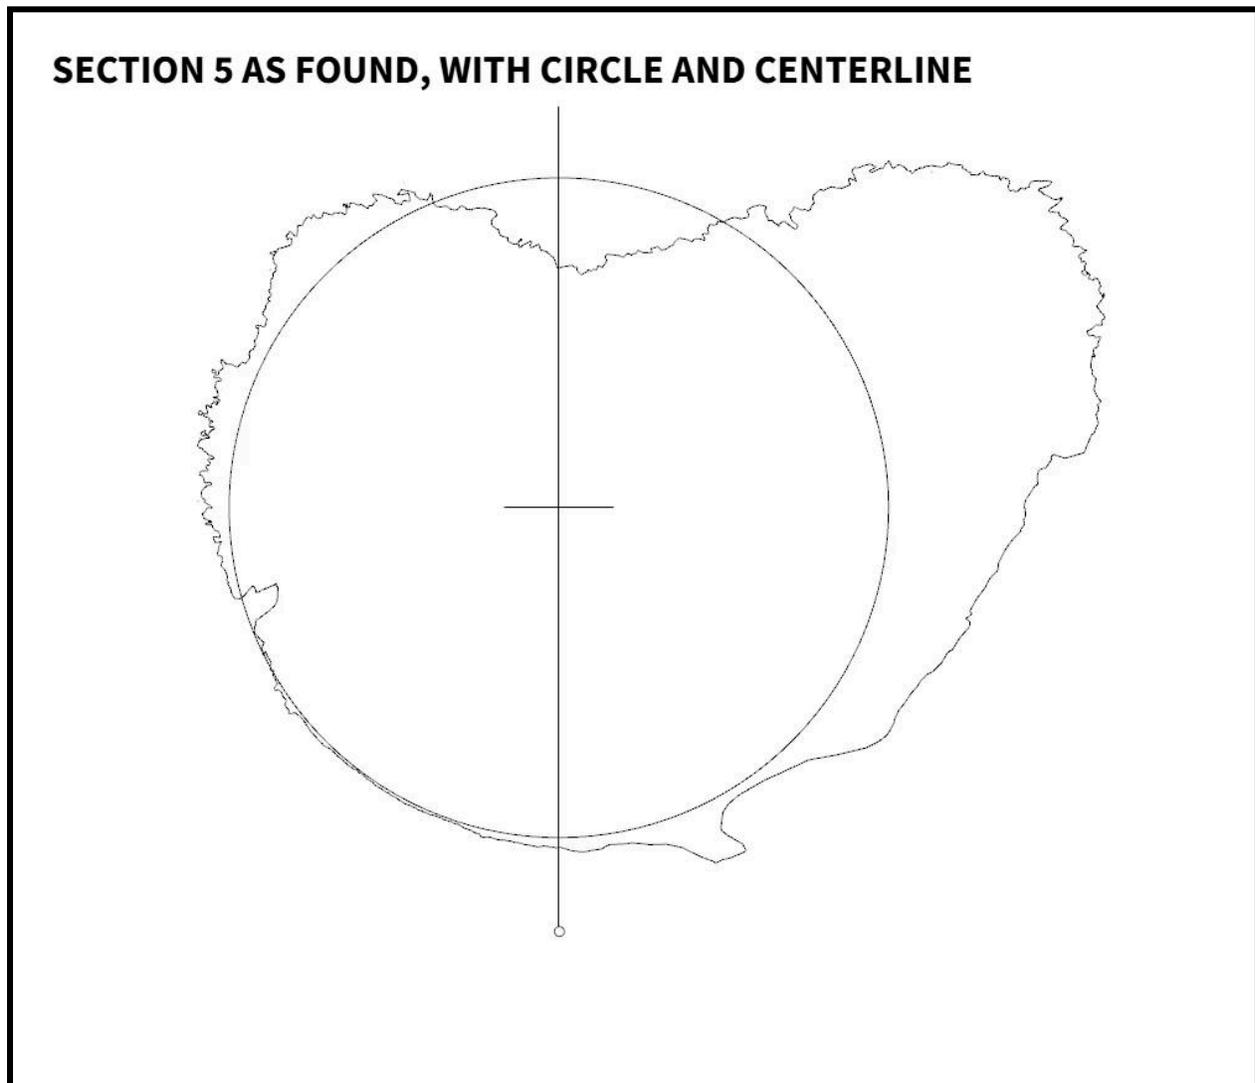
- iv. If we take that center to be on the centerline of the canoe, then we can draw in that centerline and use it in the production of sectional drawings as described below.

[Figure 10. Section 5 As Found with circle, center of tree and centerline.]

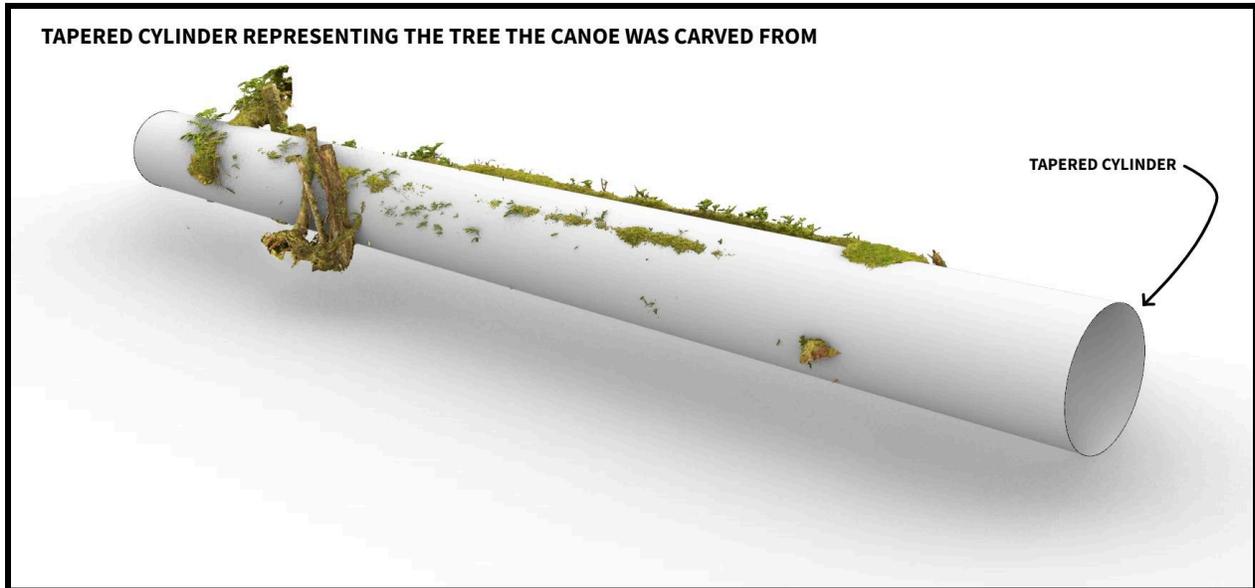
- vi. Since we know the diameter of the butt cut at the stern end of the canoe and the diameter of the treetop at the bow end of the canoe, we're able to draw in a tapered cylinder superimposed over the canoe representing the tree that this canoe came from.

[Figure 11. Tapered cylinder representing the tree the canoe was carved from.]

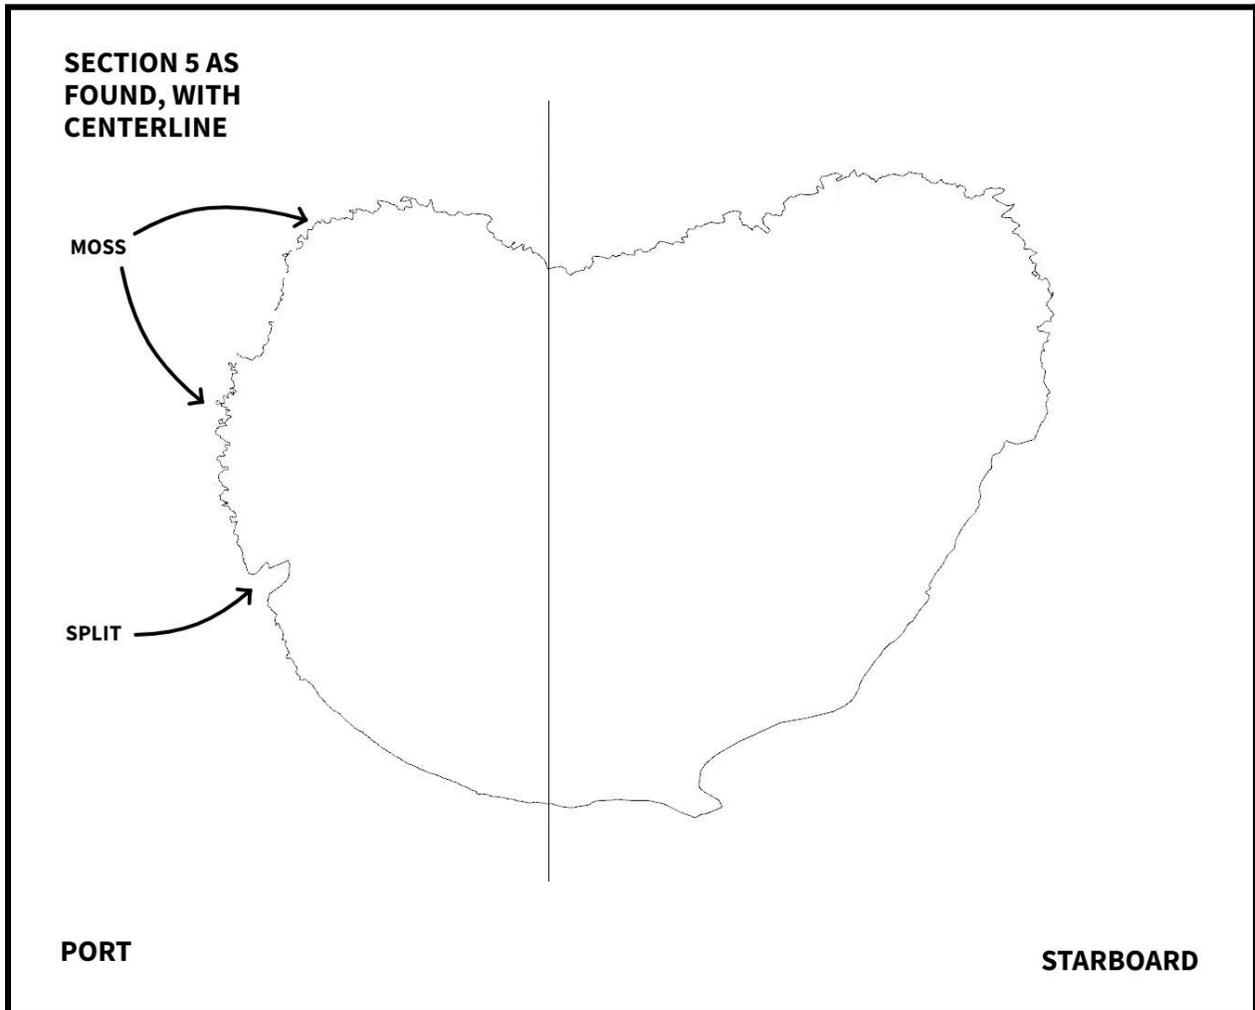
[Figure 12. Section 5 As Found with centerline.]

1. Looking at the As Found section, we see that Section 5 is in good condition relative to other sections in the canoe. It is in the middle portion of the canoe which is in better condition than the ends.
2. As described in Part 1b:
 - a. the port side is in good condition. The starboard side is tilted out away from the centerline and is less useful to this study.
 - b. On the port side about half way up from the bottom there is a split in the side of the canoe. Above this split, the canoe

has sprung slightly out away from the rest of the canoe. This split springs out more towards the stern as can be seen in other sections.

- c. Above the split, thick moss covers the side and the top edge.
- d. Below the split the smooth growth ring can be seen as described in Part 3,d,i and ii.
- e. On the starboard side the canoe has fallen out away from the centerline. From the tapered cylinder that we created to represent the tree that the canoe was carved from, we can approximate the size of the tree at this section. When we draw in the circle representing the tree at this section, we see that the starboard side falls outside that circle. This shows the amount to which the starboard side has moved.

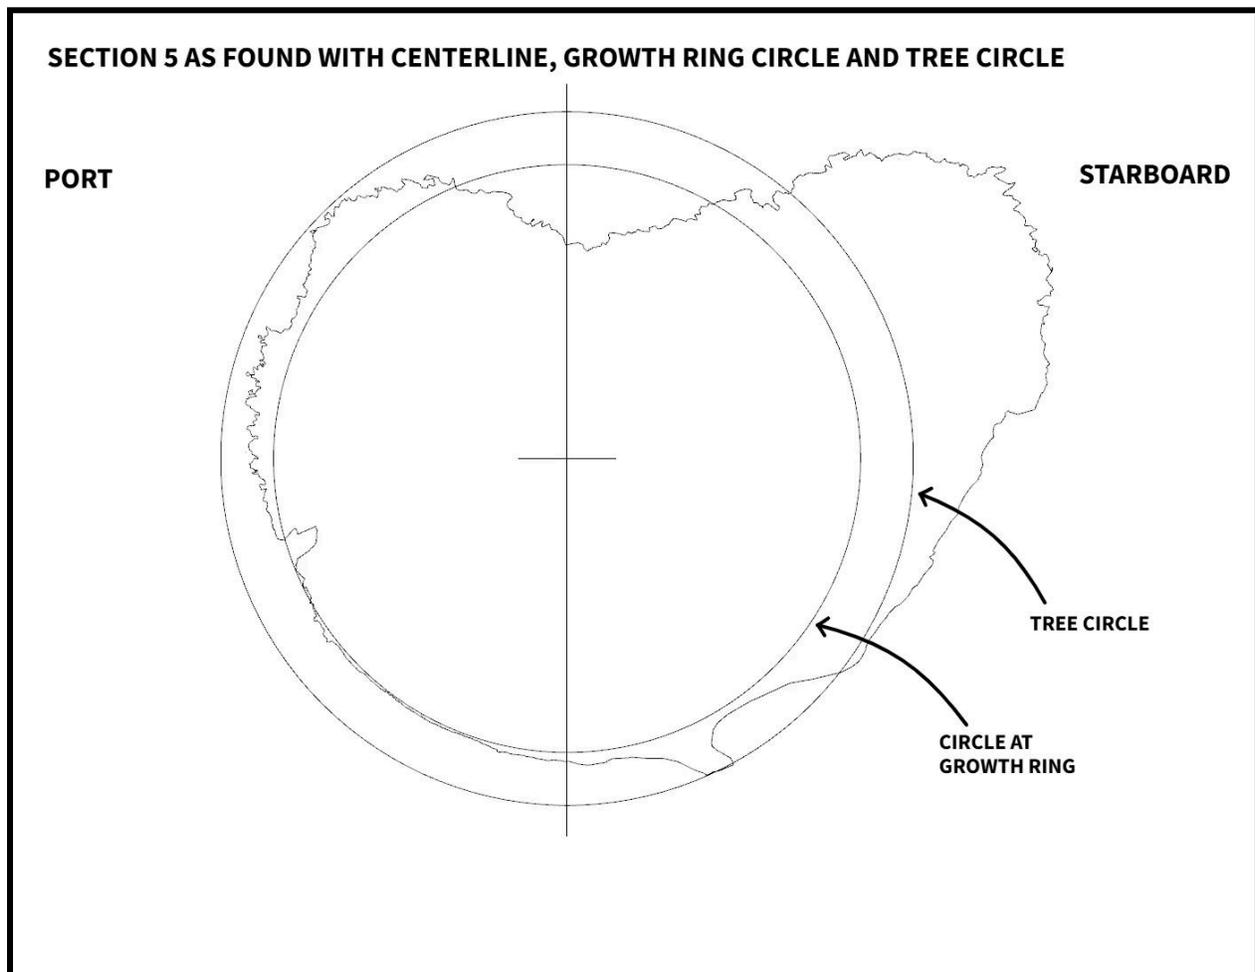
[Figure 13. Section 5 As Found with centerline, growth ring circle and tree circle.]

3. Referring again to this tapered cylinder representing the tree, we can estimate the size of the tree at Section 5. The "TREE CIRCLE" in this image represents the size of the tree at Section 5. The diameter of the tree at Section 5 is 1 meter. The diameter of the canoe is .84 meters. The difference in diameter is .16 meters. So, it appears that .08 meters or 3 1/8" has been removed from each side of the canoe.
4. In the cleaned section we've drawn an estimation of the canoe's shape now. We've drawn in the clean arc of the growth ring low on the port side. Above the split on the port side, we've drawn in an approximation of the curve under the moss. This upper portion is sprung out slightly from the centerline. On the starboard side we've also drawn lines approximating the shape of the canoe under the moss.

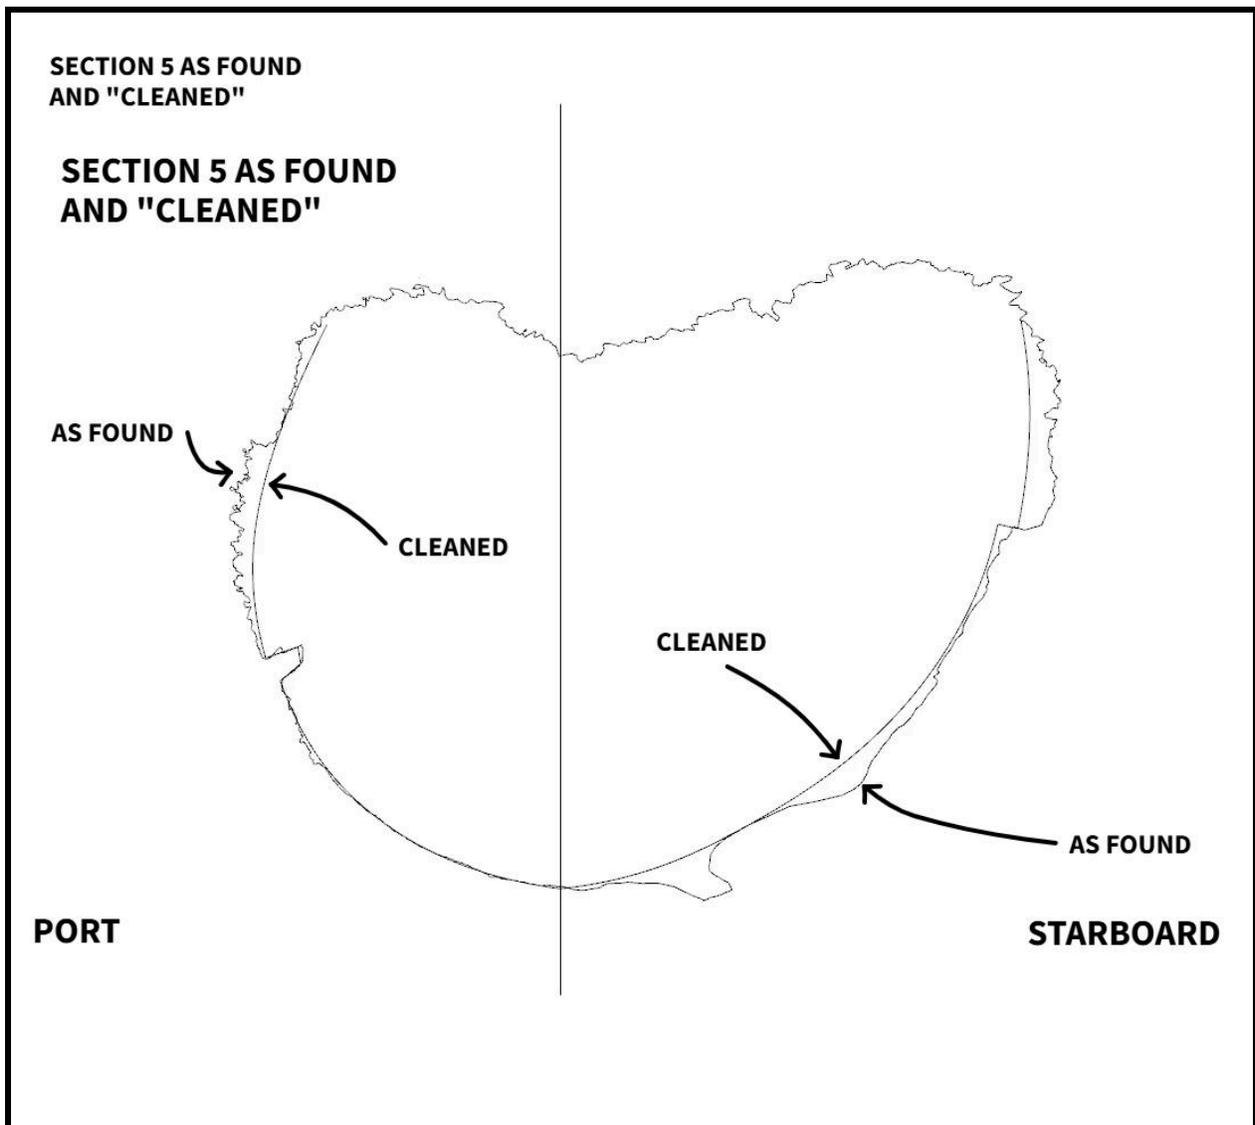
[Figure 14. Section 5 As Found and Cleaned.]

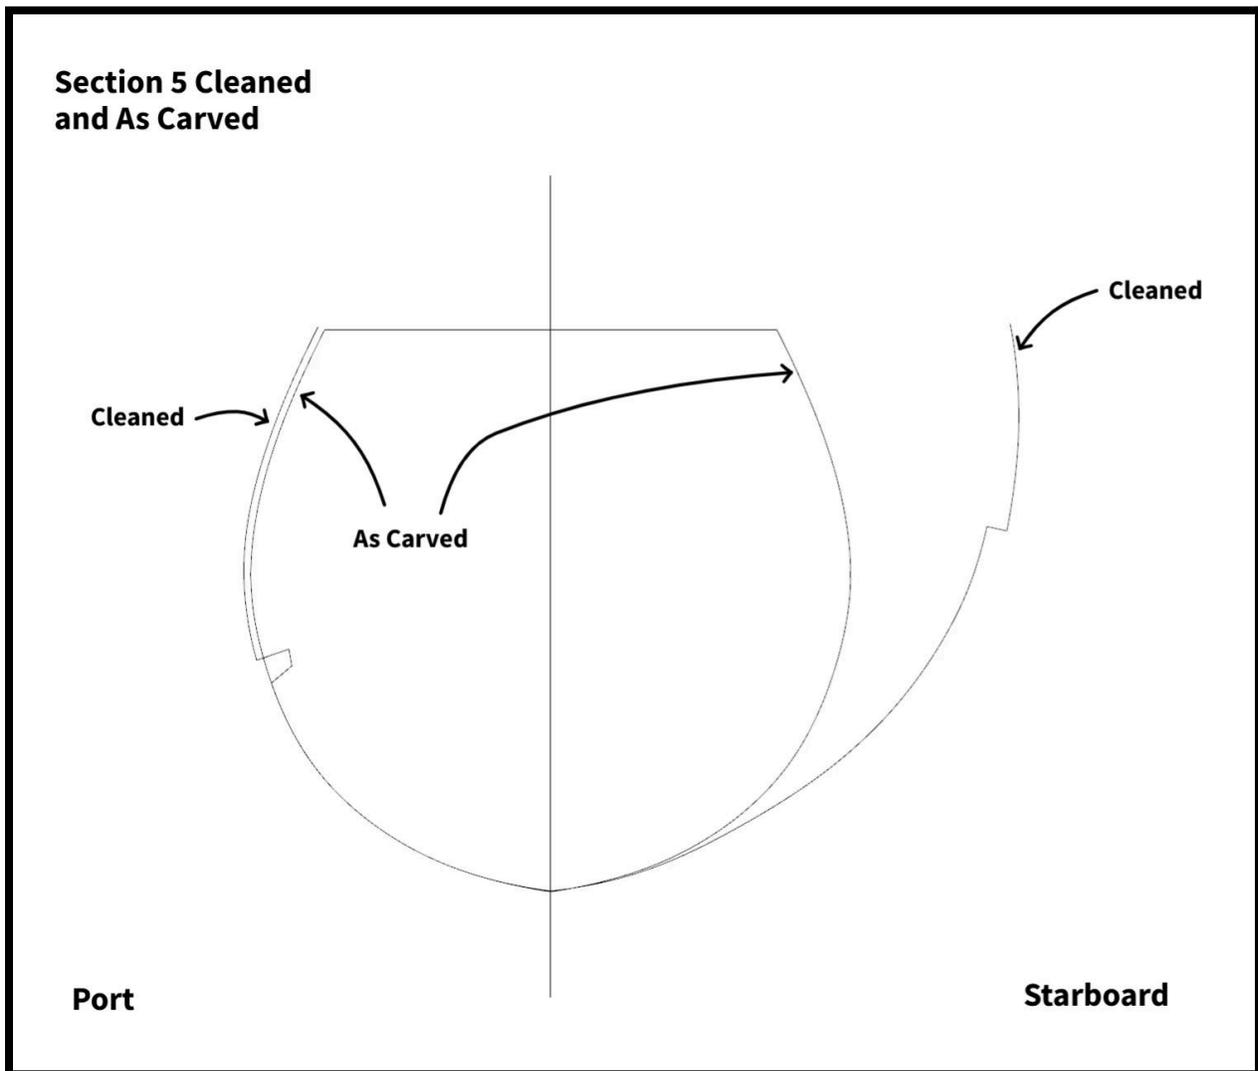
5. In the As Carved Section we've worked from the Cleaned Section. We've moved the upper part of the port side (which is split and sprung out) in to line up with the lower part of the curve. This approximates the original carved shape. Since the starboard side of the canoe has split out away from the canoe, we haven't used it. Instead, we've made a symmetrical curve on the opposite side of the centerline to represent the starboard side of the canoe.

[Figure 15. Section 5, Cleaned and As Carved.]

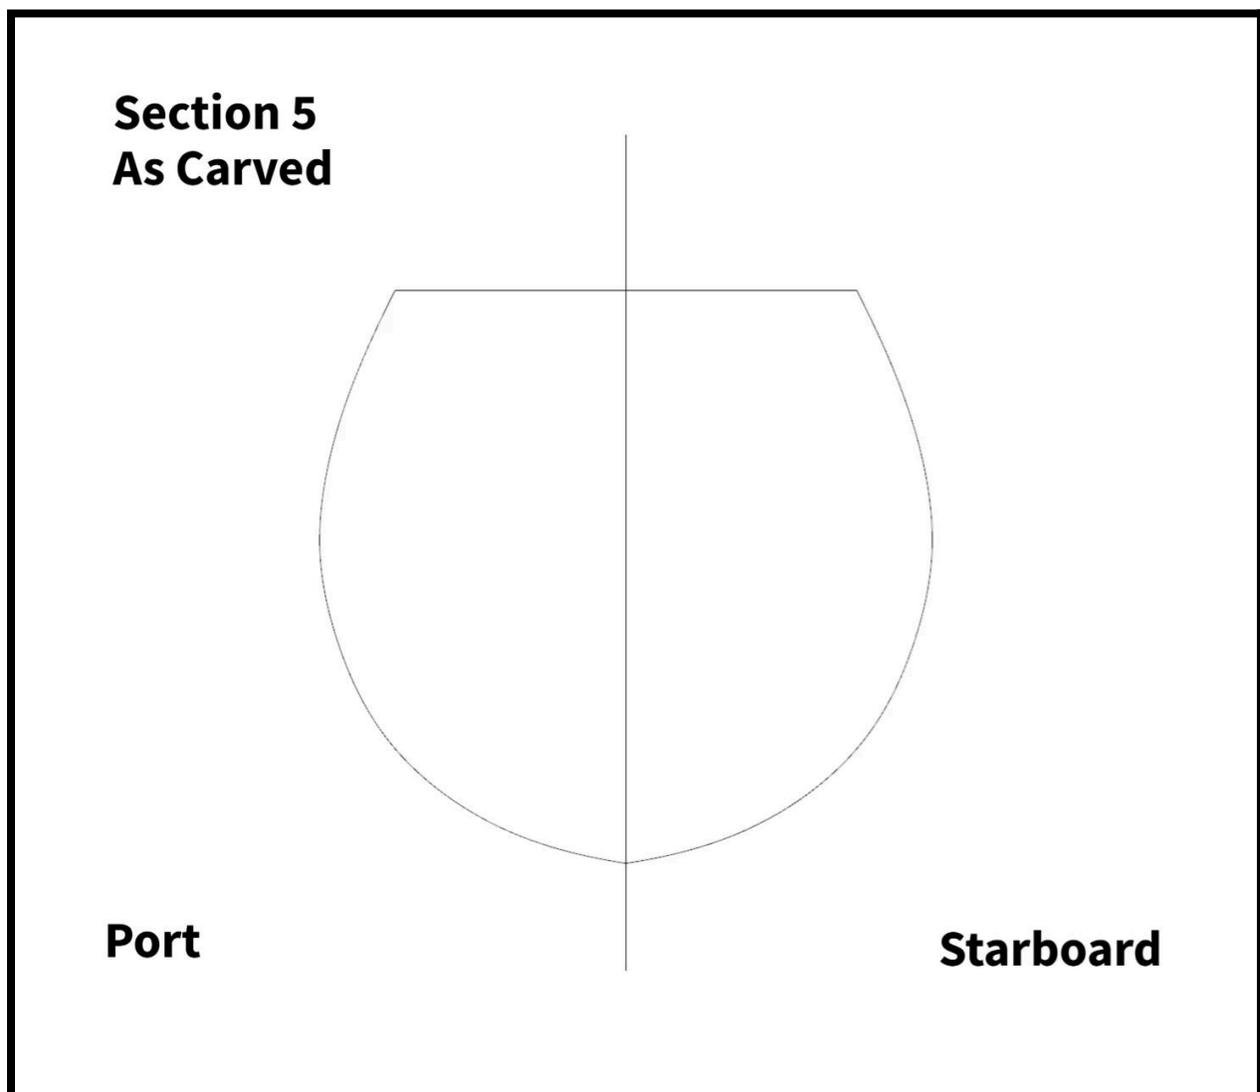
[Figure 16. Section 5 As Carved.]

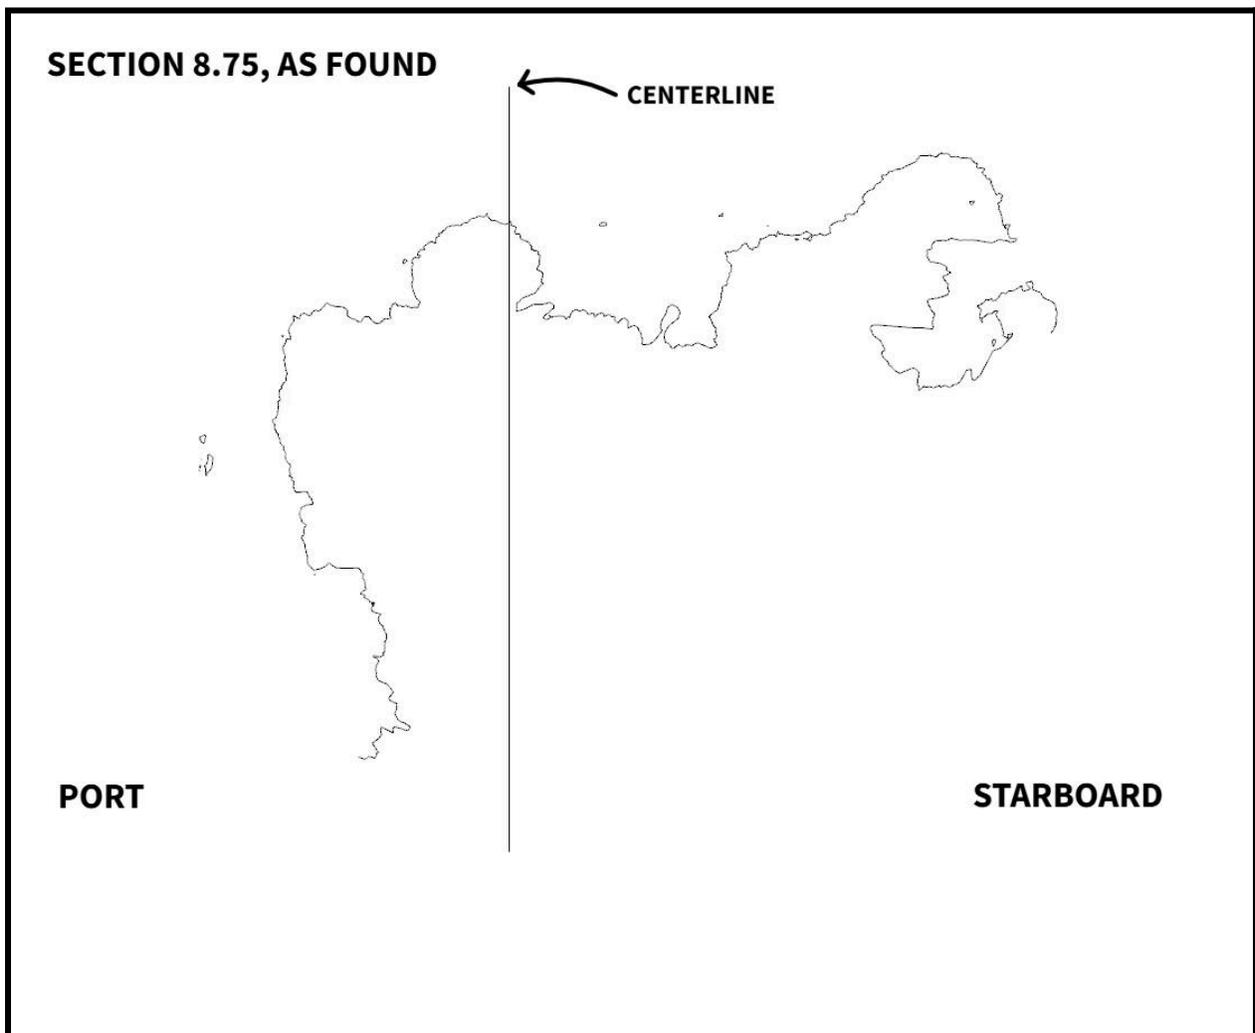
[Figure 17. Section 8.75, As Found.]

1. In the As Found section we can see evidence of some of the deterioration, defects and damage to the canoe.

- a. On the port side there is evidence of the large split in the side of the canoe. The upper part of the port side has sprung out away from the lower part. The knob shape just port of centerline is a fore-and-aft ridge, a remnant of the gunwale from which the side has split away. (This is more apparent in the sections just forward of 8.75 and in the plan view of the model.)
- b. On the starboard side the canoe is badly decayed and not much is discernible.

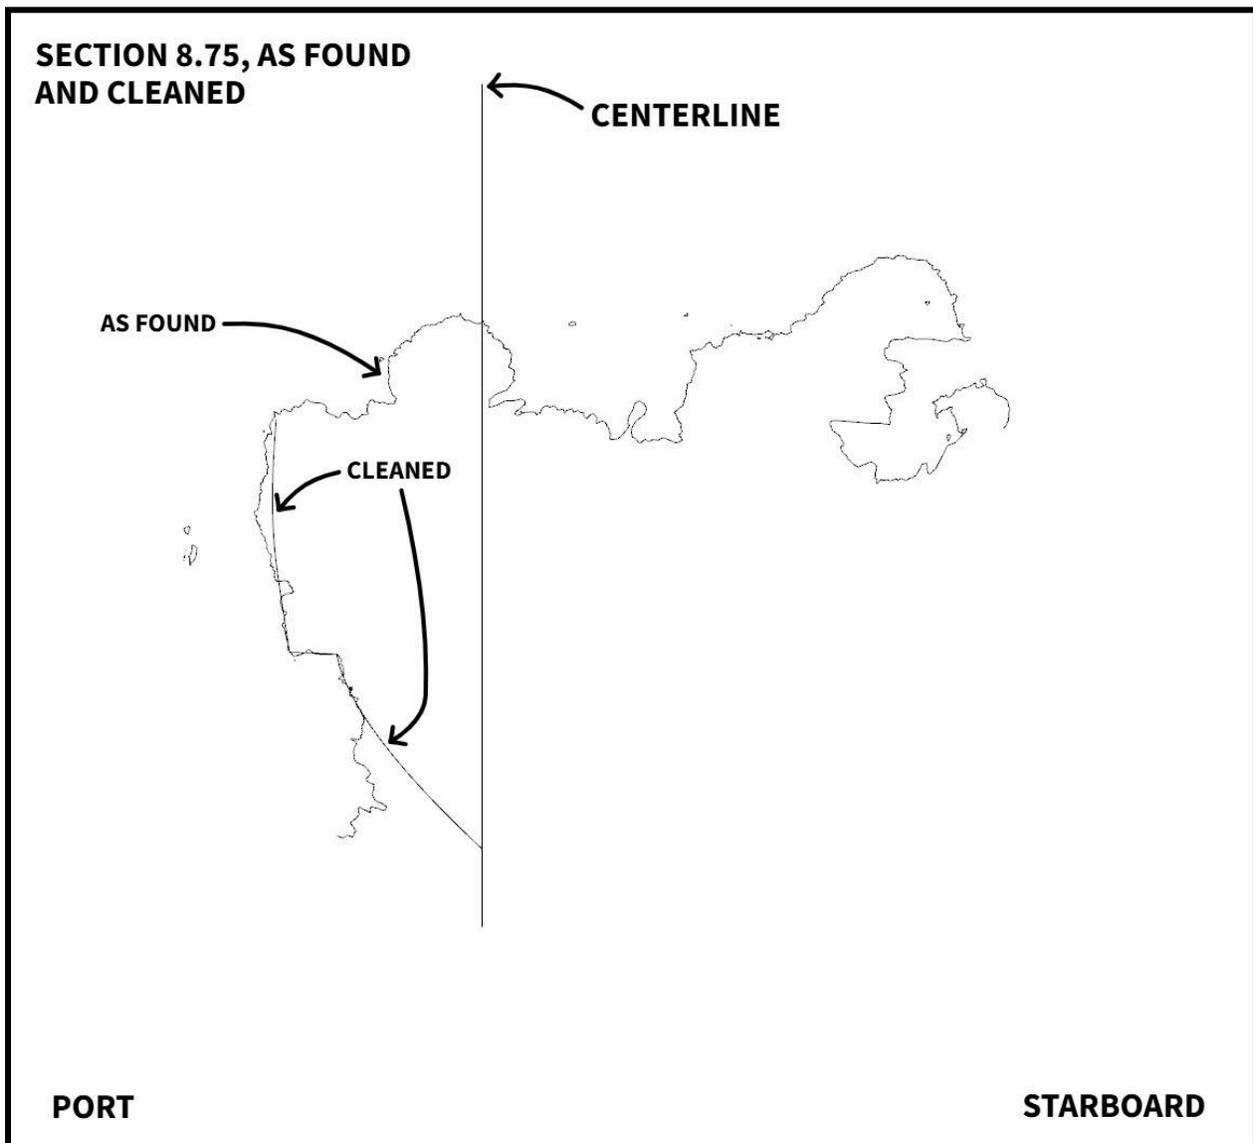
[Figure 18. Section 8.75, As Found and Cleaned.]

1. In the cleaned section we've drawn an estimation of the canoe's shape now. We've used the known center of the tree to draw in the centerline of the canoe. On the port side we've drawn the upper part of the section to remove the lumps of moss and deterioration. The lower part (below the split out upper portion) follows the shape of the As Found section then arcs in to the centerline. This lower arc is an estimation necessitated by the obstruction of the earth around the bottom of the canoe. The estimation is based on an assumption that the shape would curve into that centerline, and on the shape of the section just forward (8.5) that is visible lower and that does in fact curve in to the centerline.
- iii. As Carved Section
