Study of the Shape of the Historic Skowl Arm Haida Canoe

By V. Jason Rucker and the Haida Canoe Revitalization Group, 2025.

The objective of this report is to explain the modeling and drawing of this canoe clearly enough for others to understand, and to allow them to judge where alternative assumptions or interpretations could be made.

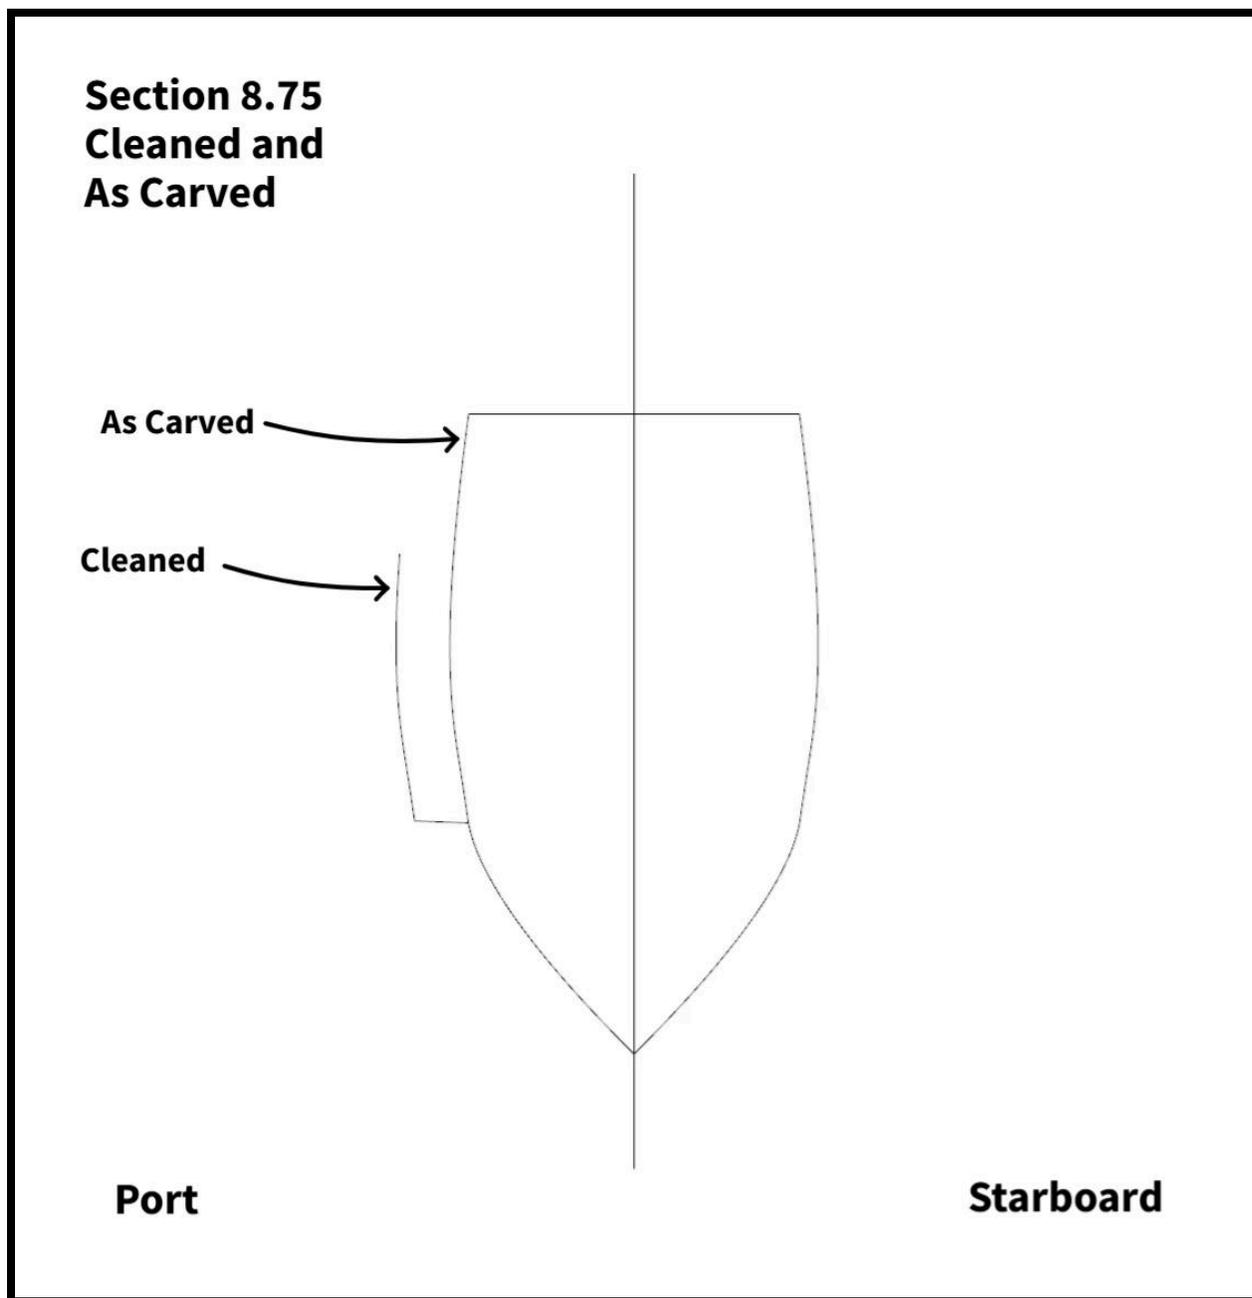
[Figure 19. Section 8.75, Cleaned and As Carved.]

1. In the As Carved Section, on the port side we've moved the split-out curve inboard to line up with the lower curve to approximate where it would have been. This curve now matches up pretty well with the "knob" of the gunwale that the outer portion split away from. We've assumed that that knob represents the upper portion of the gunwale, and that the outer portion has deteriorated to a lower level, so we've extended the curve to that

knob's height. Originally the gunwale was probably even higher, as deterioration of that upper edge is visible in profile. After creating this cleaned up line, we mirrored that line on the centerline to create a line for the starboard side. There is not much left on the starboard side to work with at this section. It is split out away from the center and has been subsumed by earth and branches and debris and the bulging base of a tree growing alongside the canoe.

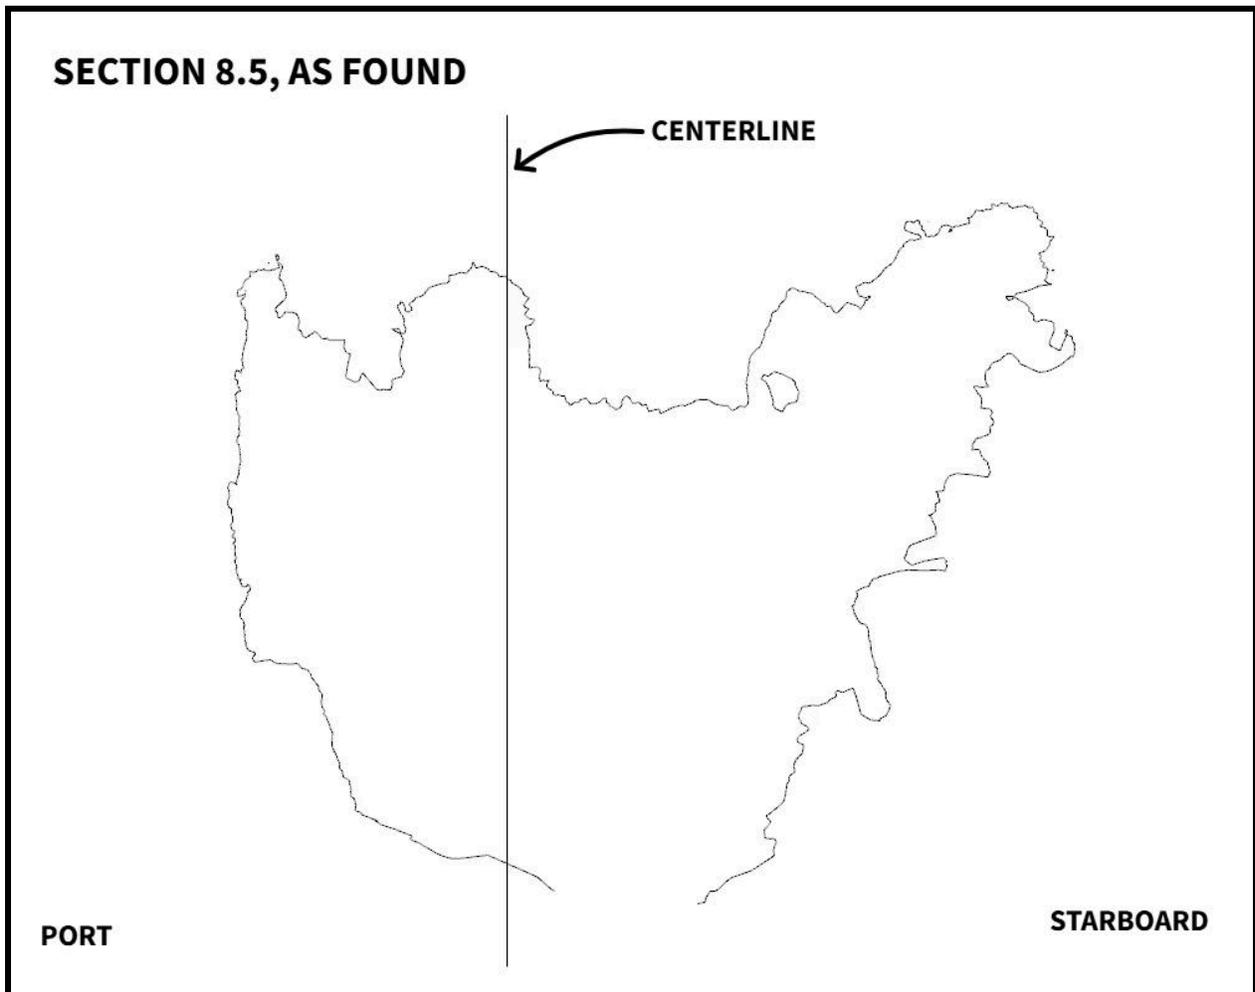
[Figure 20. Section 8.5, As Found.]

1. Section 8.5 shows further evidence of the deterioration of the stern of the canoe. The port side outboard edge is higher than in section 8.75 and is more obviously split away from the knob. The starboard side isn't as buried in debris, and so it shows the way that the arc of the side of the canoe curves in to the centerline. This section also shows the way that the starboard side has split away from the center of the tree and canoe.

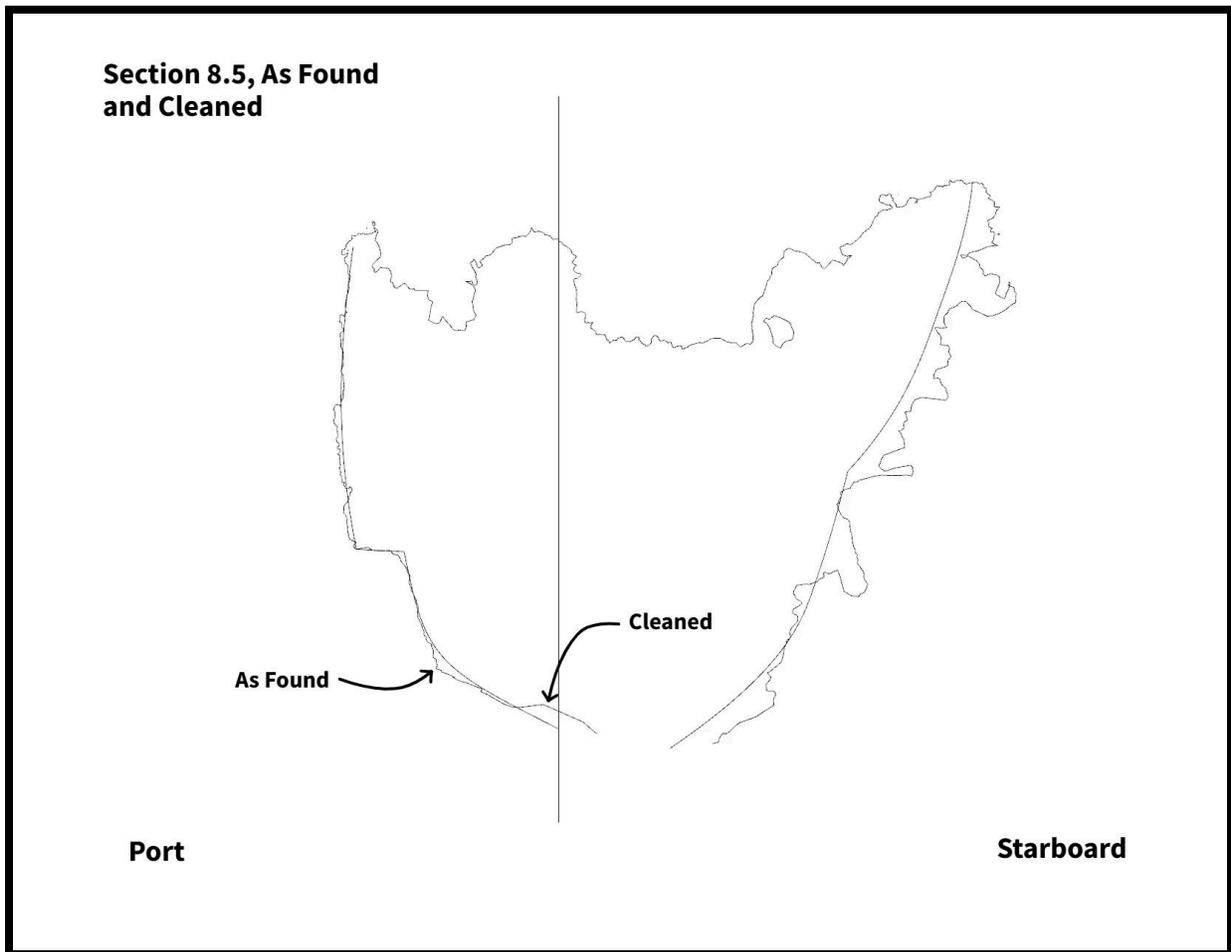
[Figure 21. Section 8.5, As Found and Cleaned.]

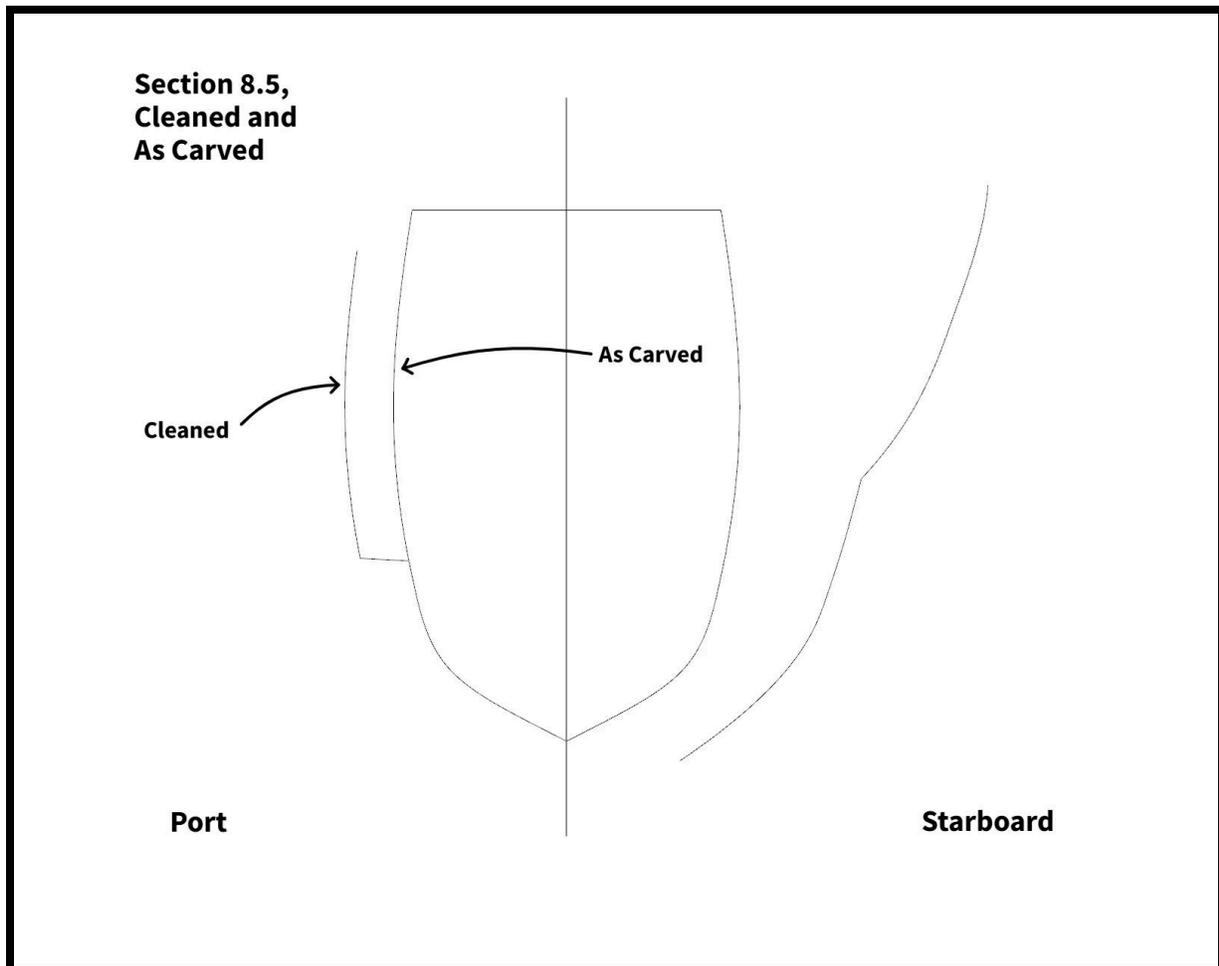
- ii. The Cleaned and As Carved sections were developed as in Section 8.75, though here the lower portion is more visible, allowing greater confidence in the curve. As in Section 8.75, the upper edge is deteriorated and was probably originally higher.

[Figure 22. Section 8.5, Cleaned and As Carved.]

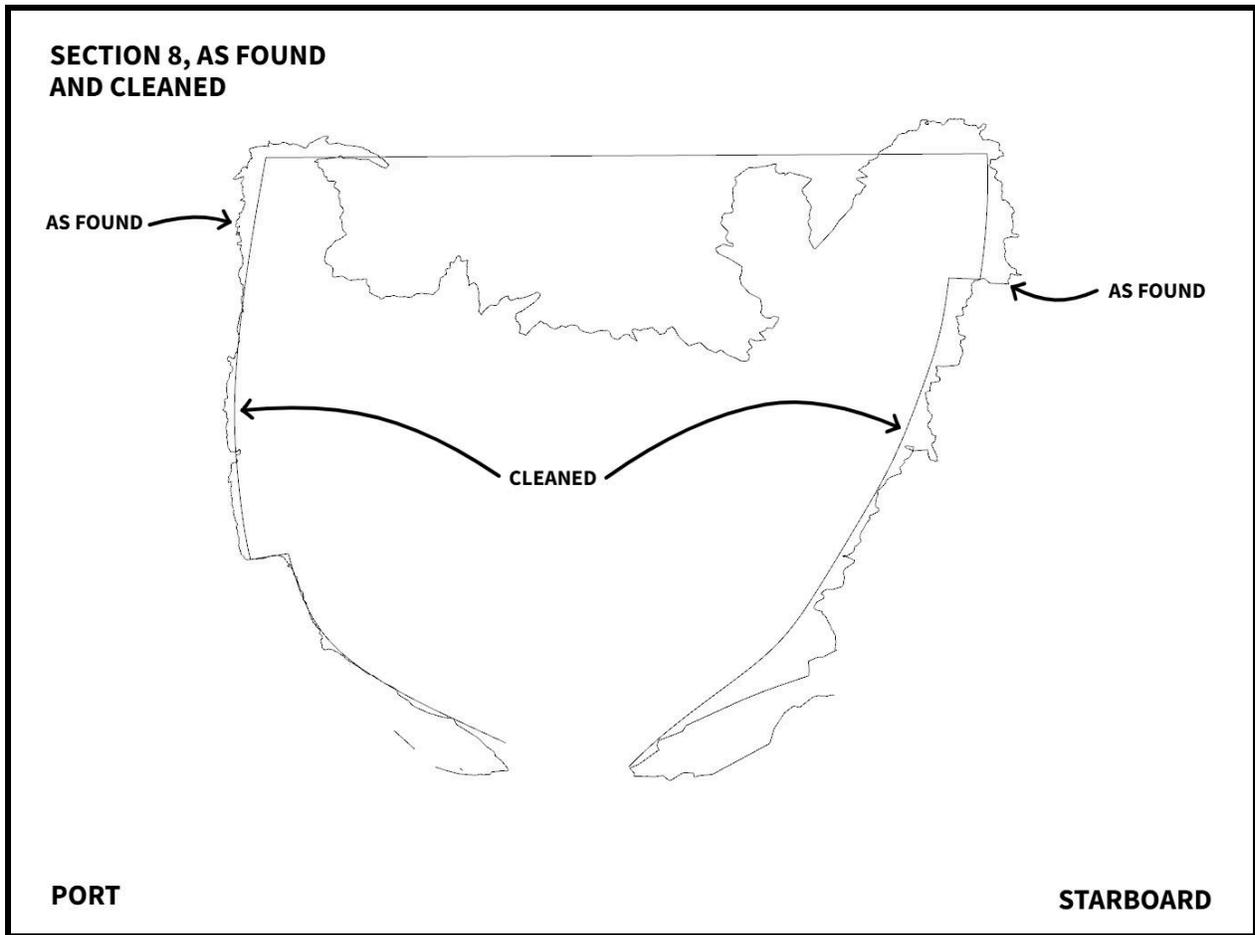
1. Section 8 continues to show the split in the port side with the upper portion sprung out away from the lower. On the starboard side, we see that the whole side is split and tilted out. We also see a remnant “knob” nearer the centerline where the side has split away from an original gunwale. (These knobs appear as ridges and are obvious in plan view.)

[Figure 23. Section 8, As Found and Cleaned.]

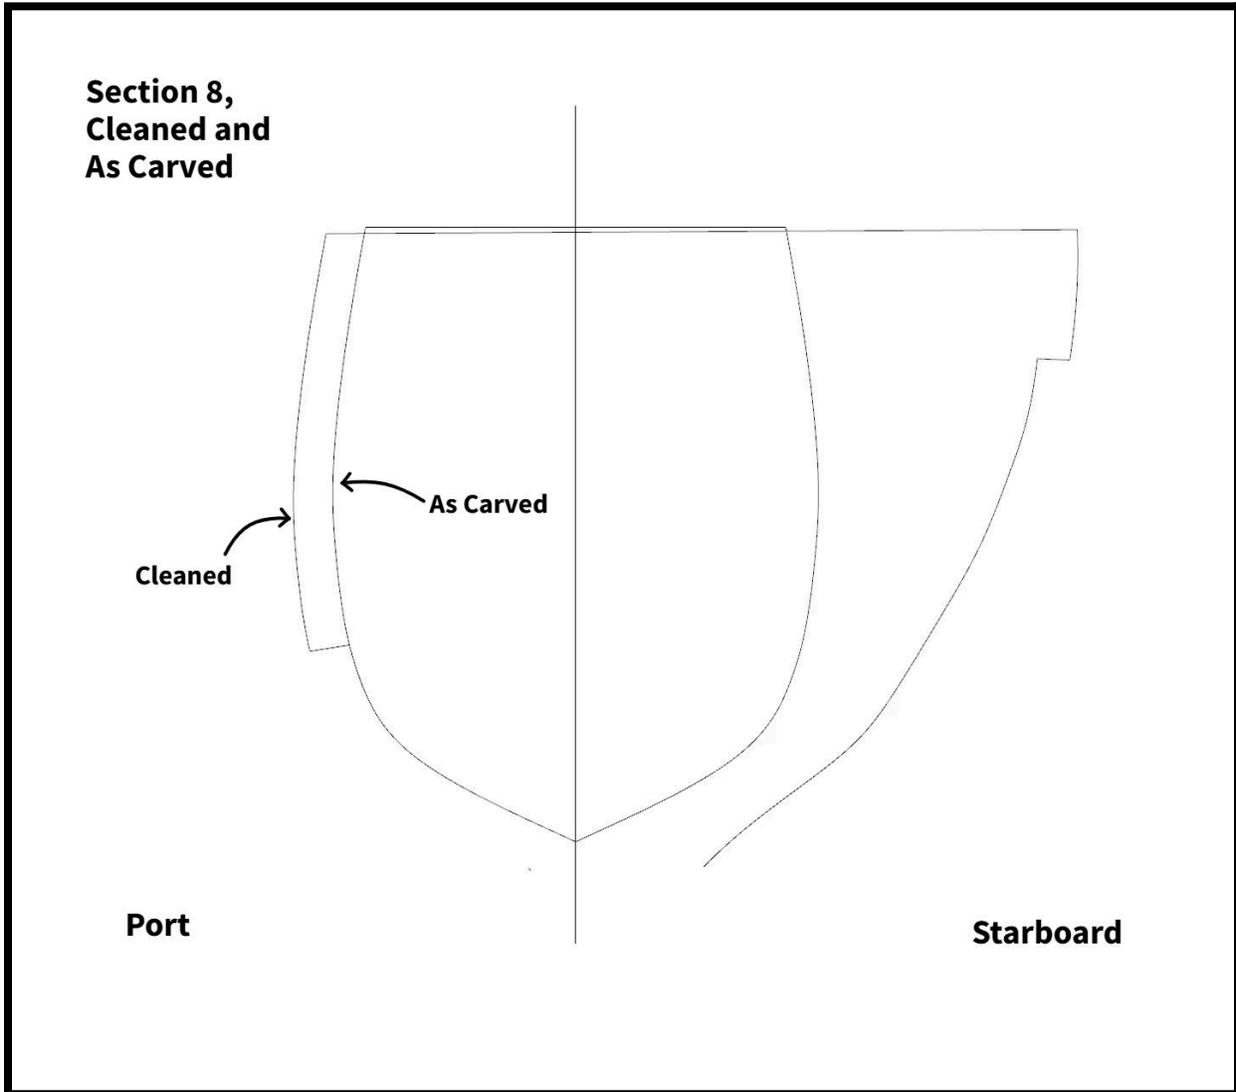
[Figure 24. Section 8, Cleaned and As Carved.]

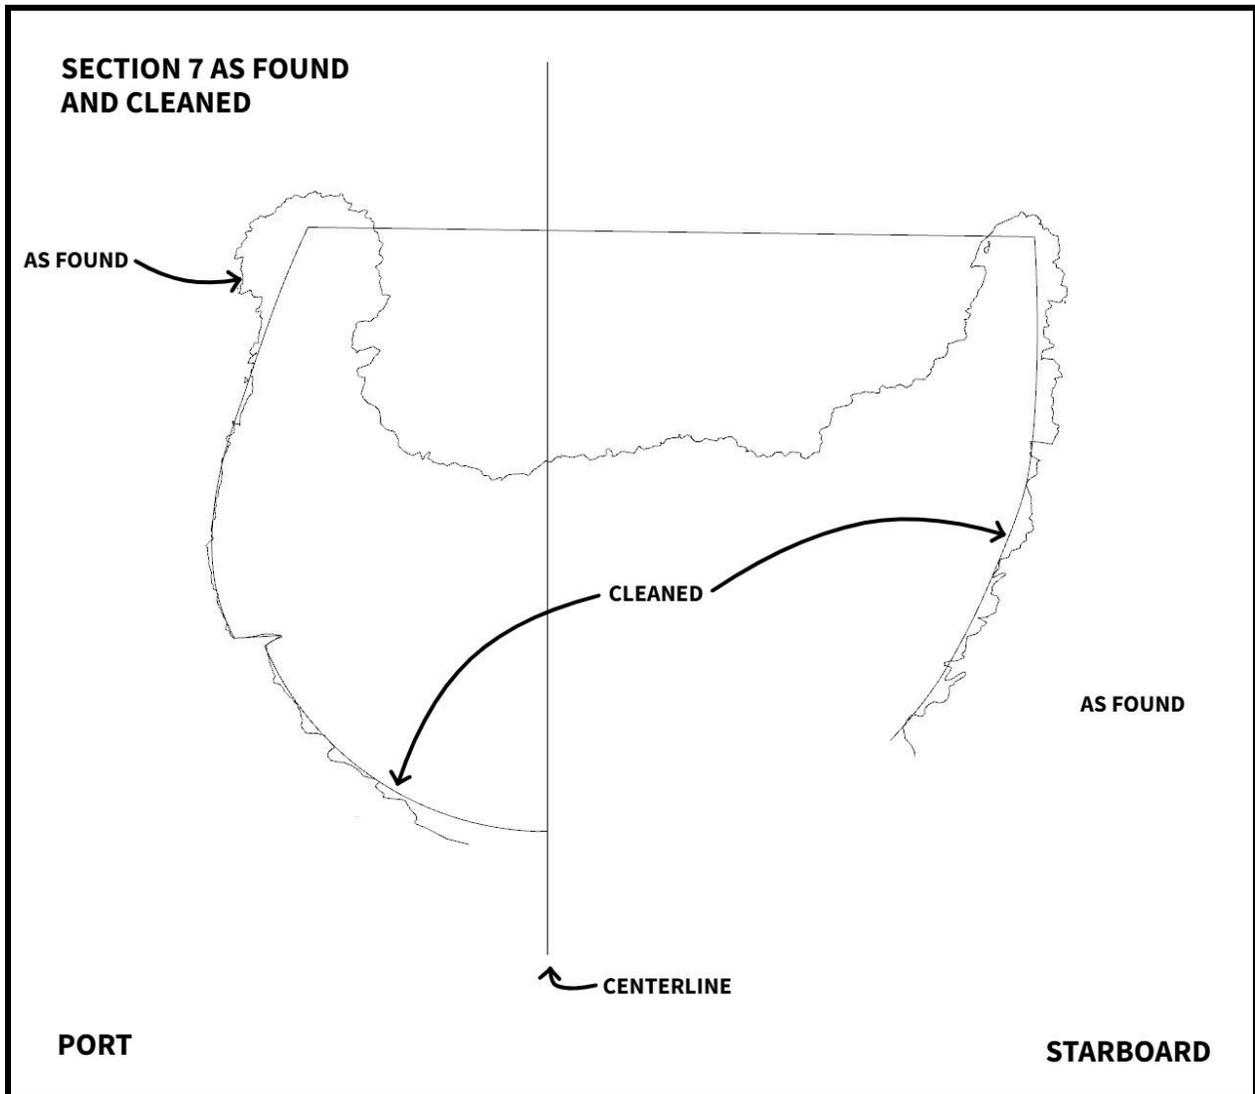
1. Section 7 is less deteriorated than sections 8, 8.5 and 8.75. We still see the starboard side badly split out away from the center, but the side is more intact. The port side is more obviously intact. It still has the split, with the upper portion sprung out, but it is not as badly sprung as sections 8 and 8.5. We also see the round shape of the midship portion of the canoe.

[Figure 25. Section 7, As Found and Cleaned.]

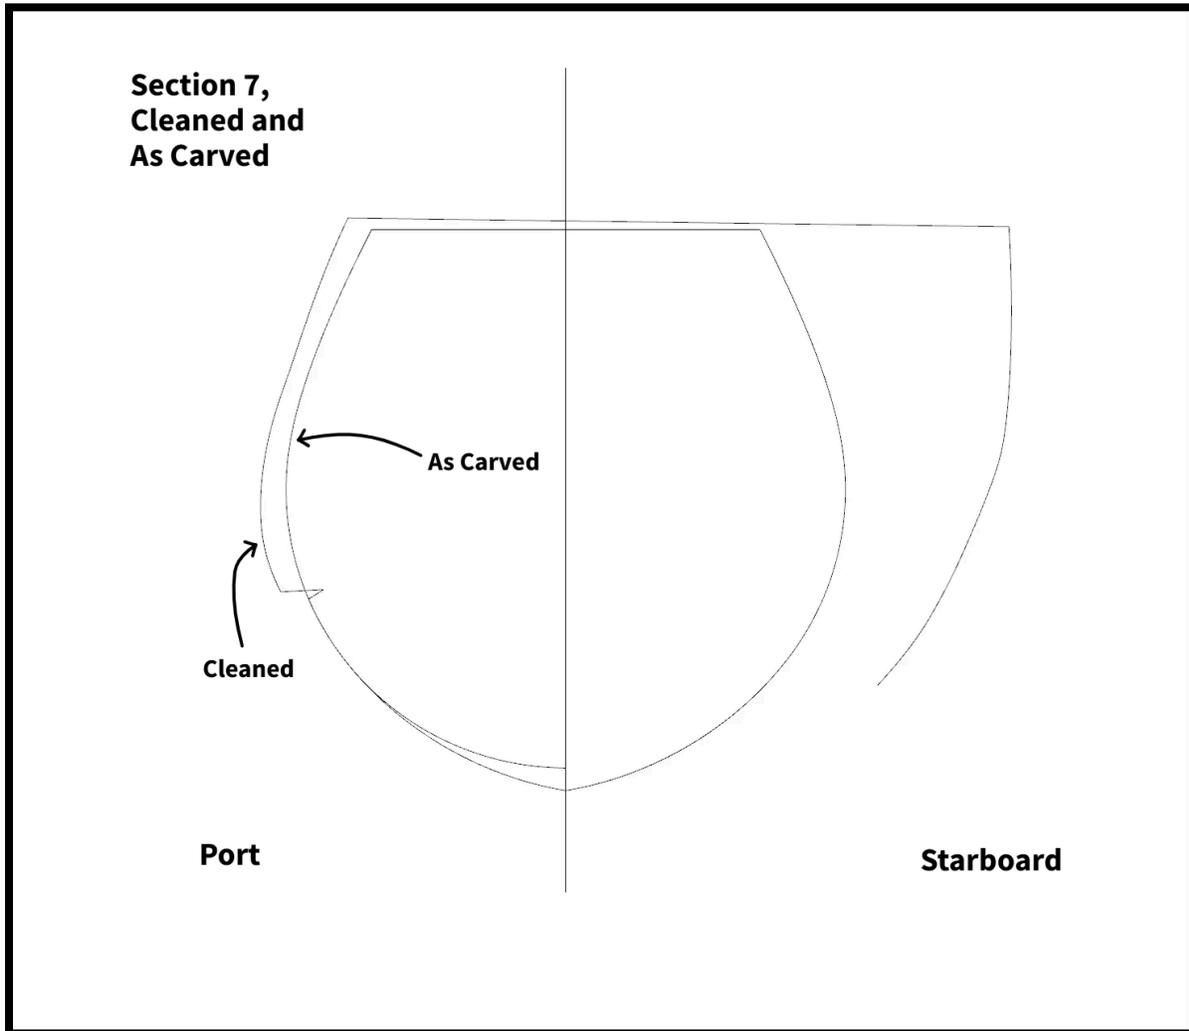
[Figure 26. Section 7, Cleaned and As Carved.]

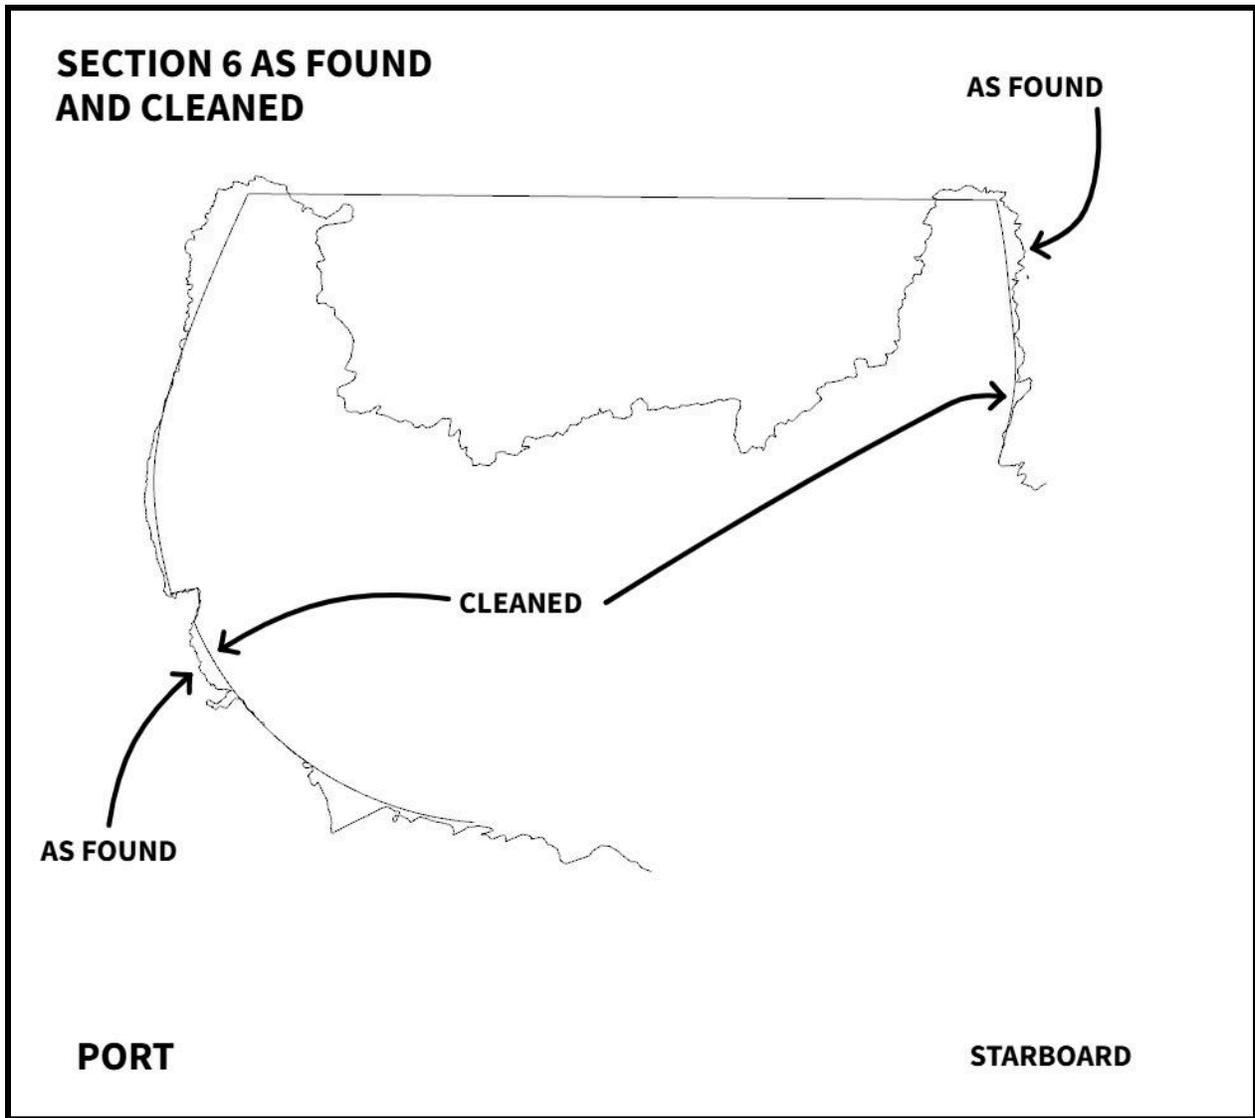
1. Section 6 is in relatively good shape. The port side shows the round shape of the midsection shape of the canoe, minimal springing out of the upper split portion. Starboard side is visible high, but obscured in its lower portions.

[Figure 27. Section 6, As Found and Cleaned.]

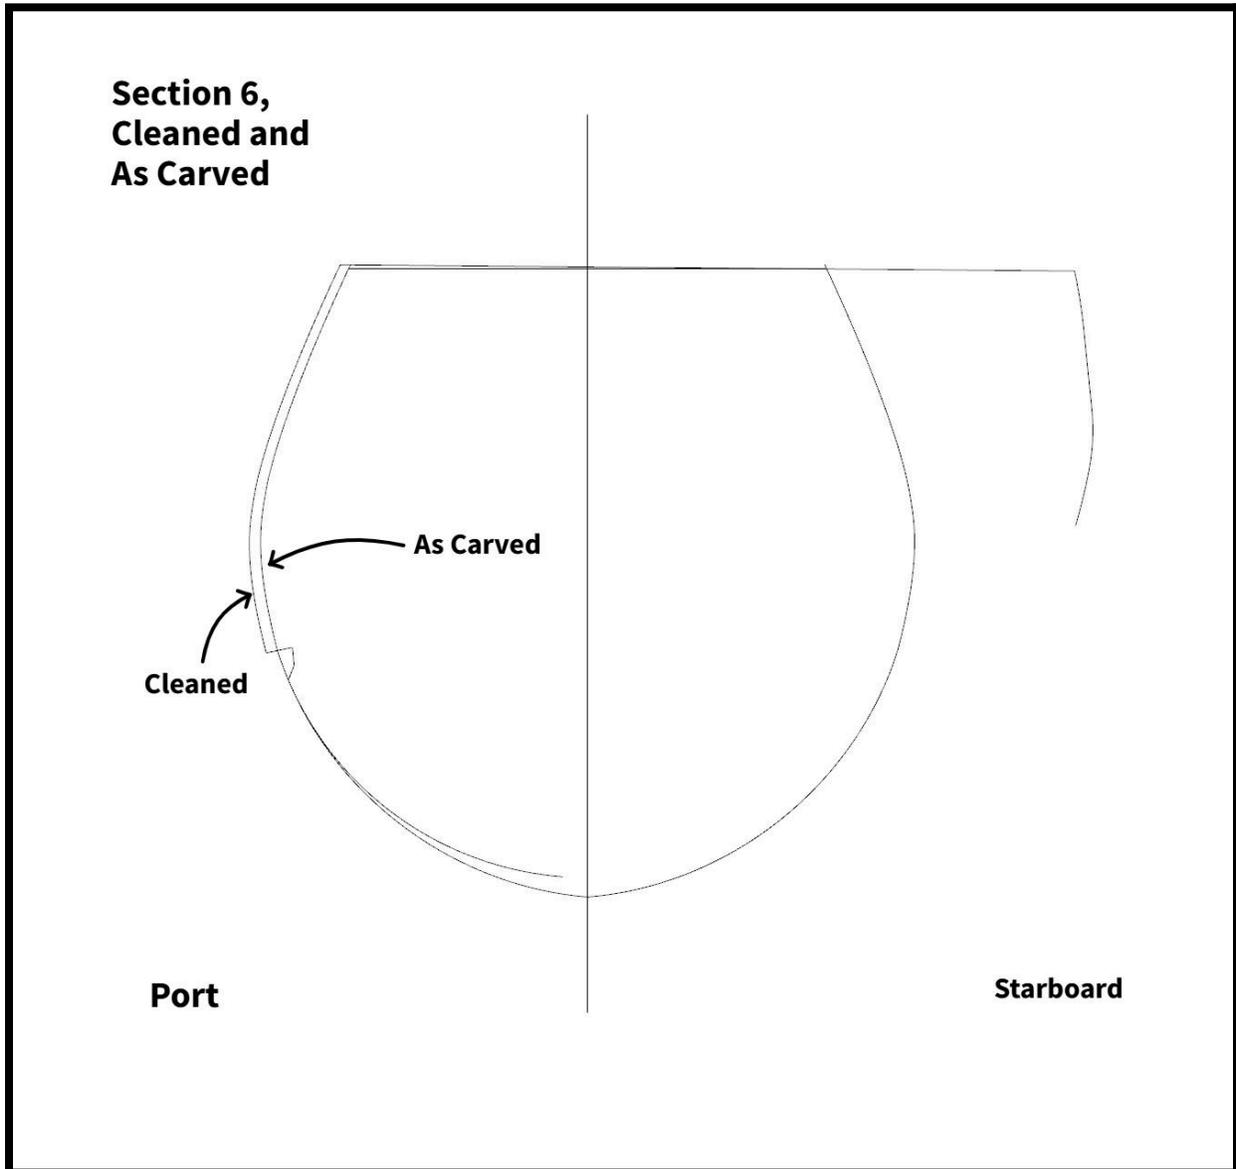
[Figure 28. Section 6, Cleaned and As Carved.]

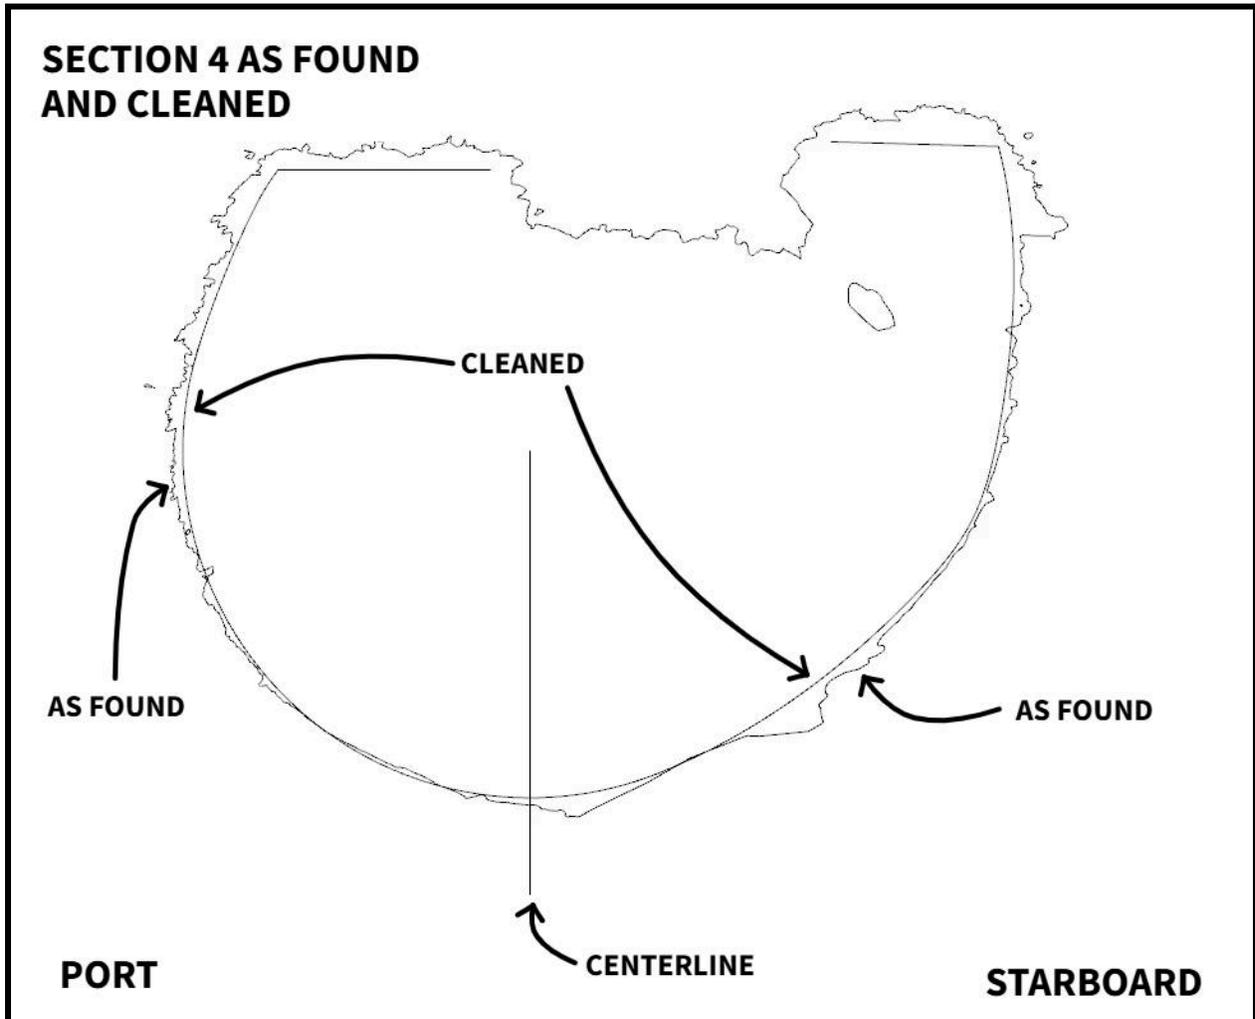
1. Section 4 is in relatively good condition. On the port side, the split is still present, but the side is not sprung out.

[Figure 29. Section 4, As Found and Cleaned.]

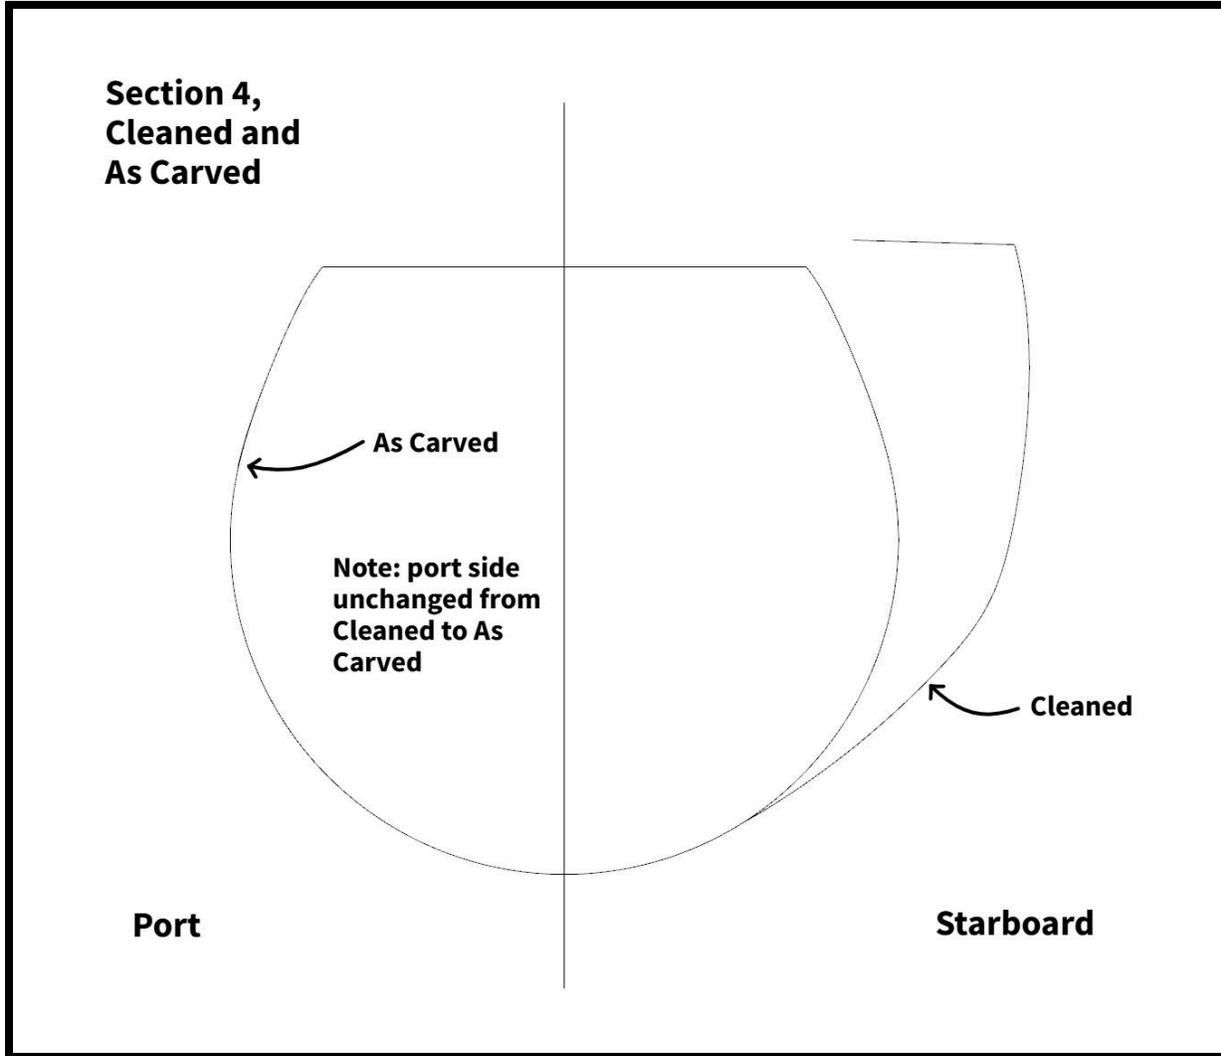
[Figure 30. Section 4, As Carved and Cleaned.]

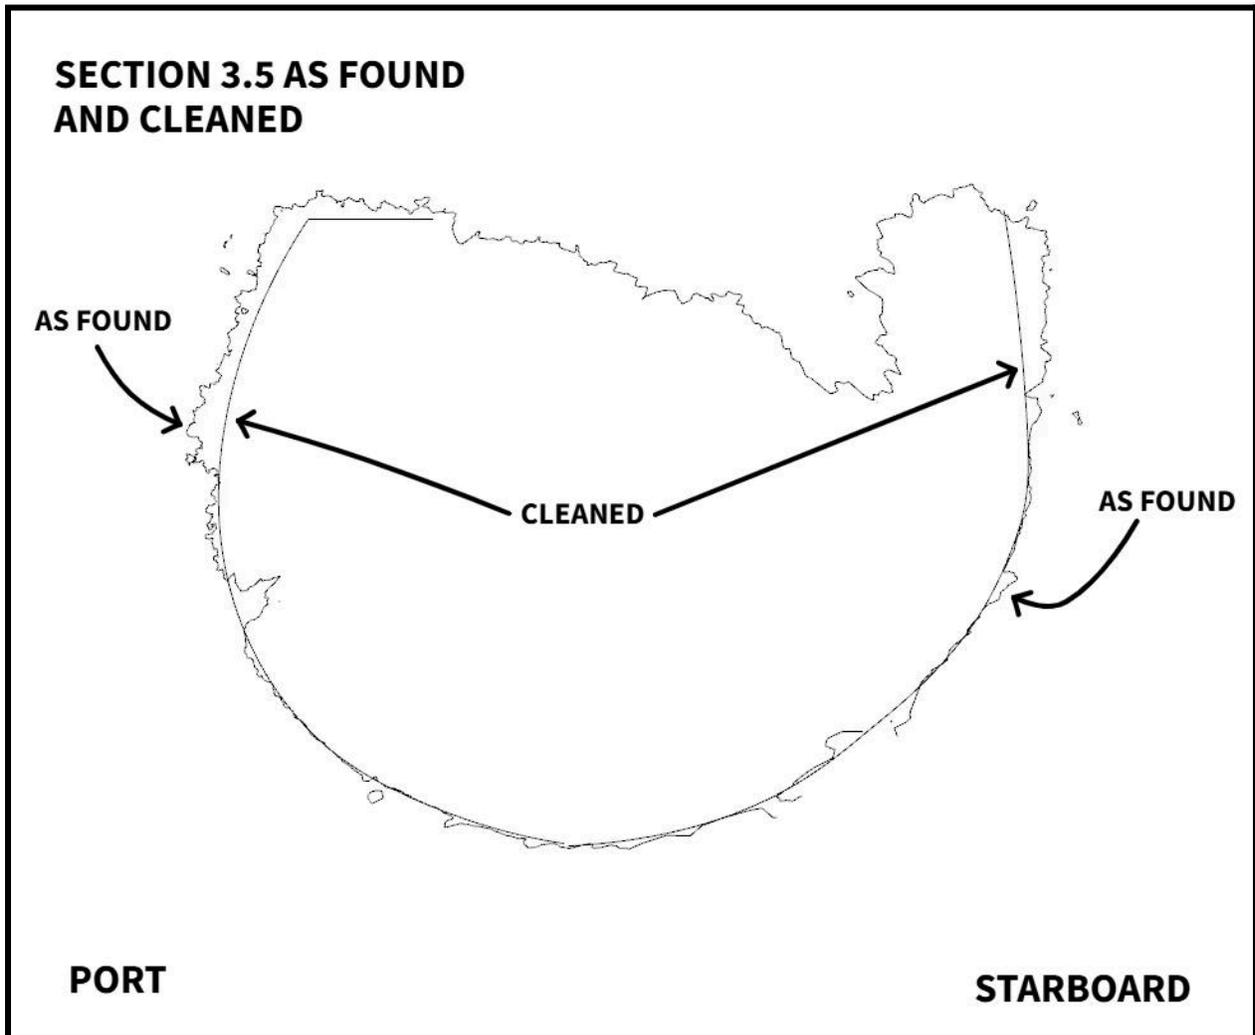
1. Section 3.5 is in relatively good condition. As in section 4, on the port side, the split is still present, but the side is not sprung out.

[Figure 31. Section 3.5, As Found and Cleaned.]

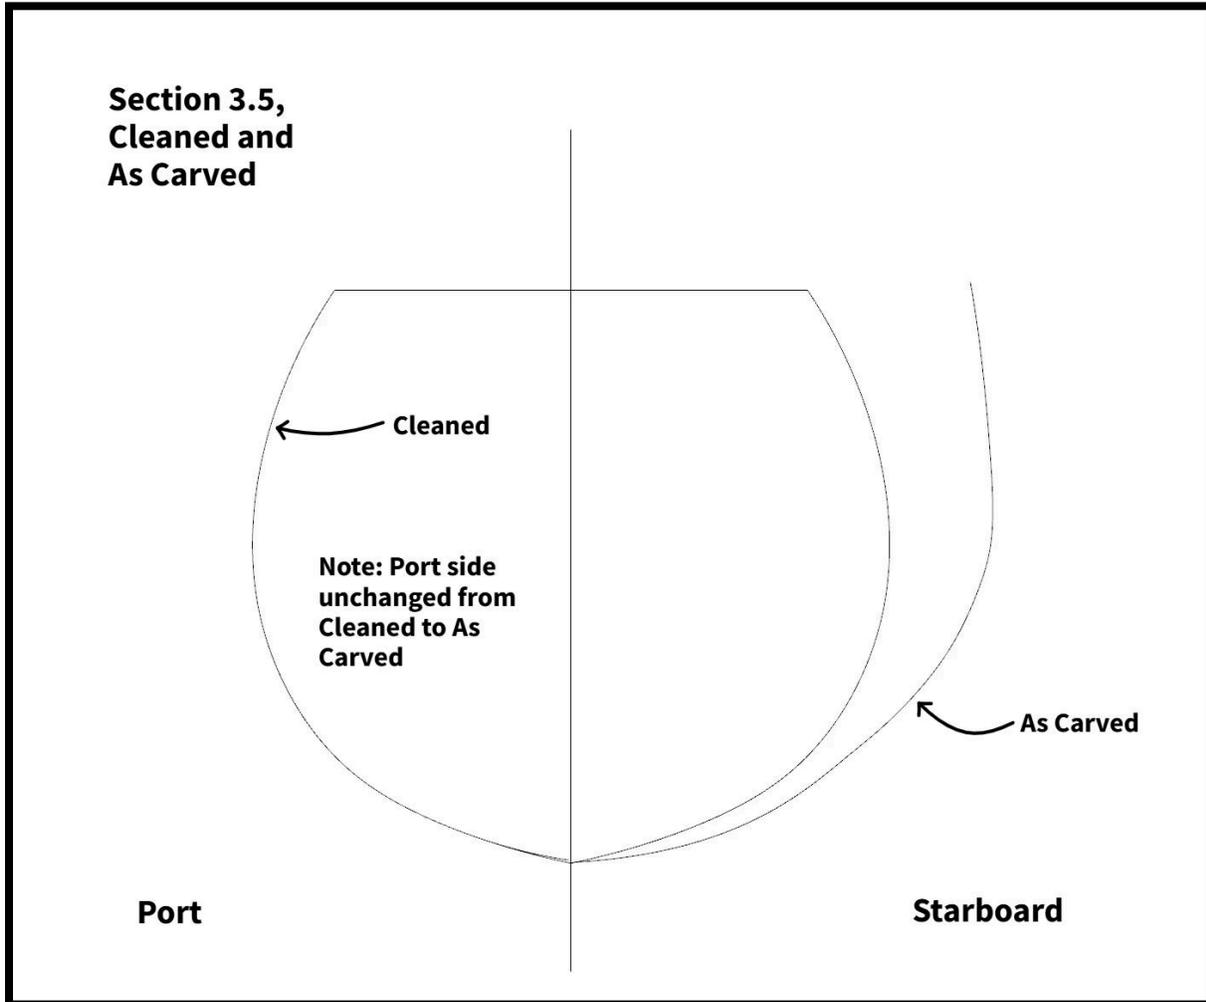
[Figure 32. Section 3.5, Cleaned and As Carved.]

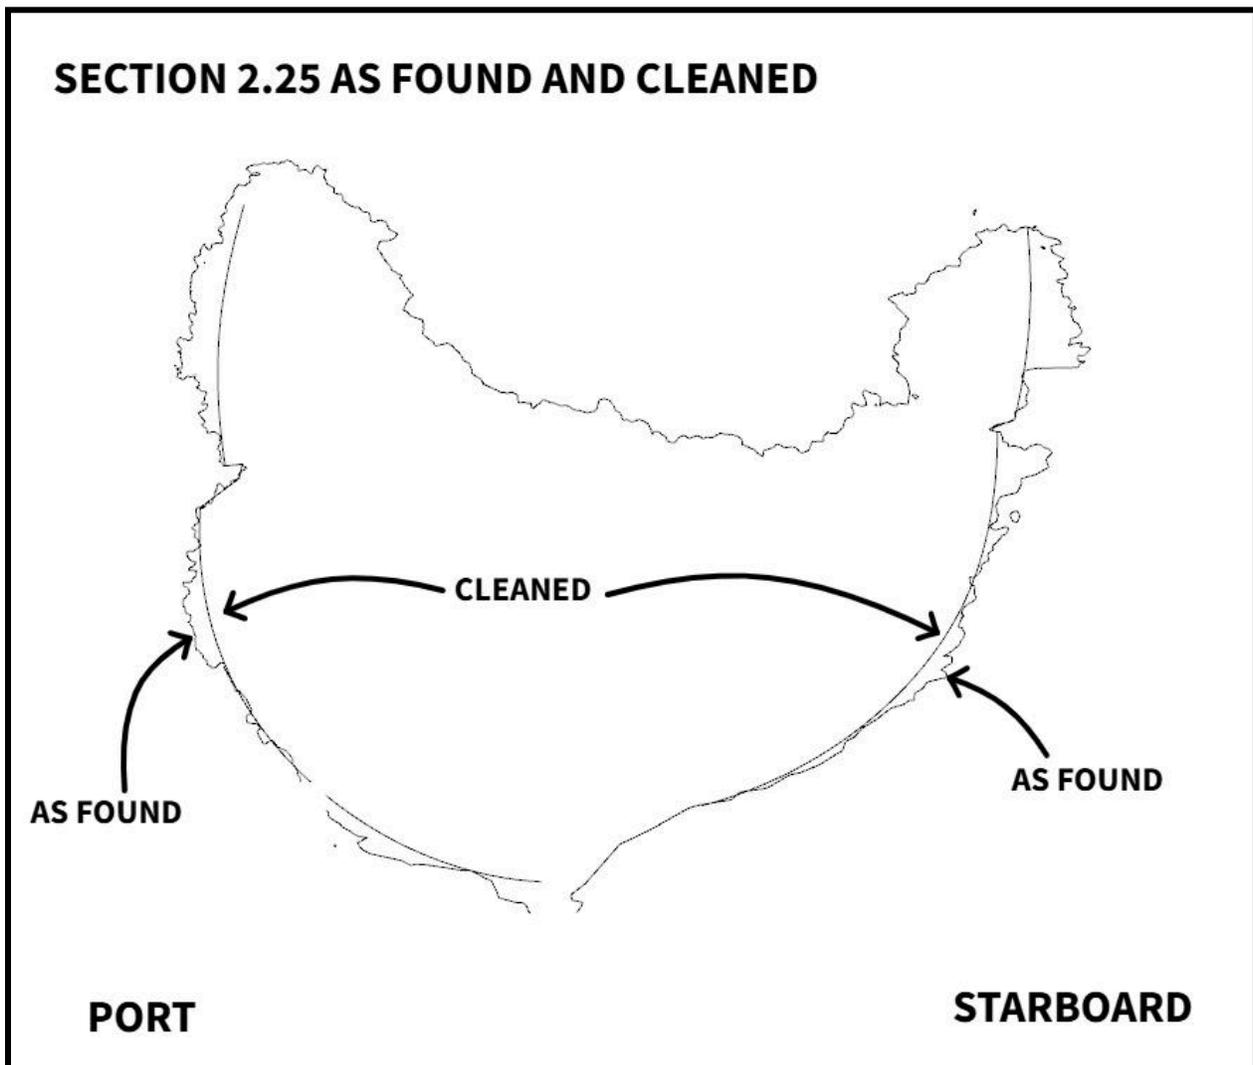
1. In section 2.5 the split in the port side results in the lower portion springing outboard rather than the upper portion. We see the beginning of the transition from the round midship section to the hollow of the ends.

[Figure 33. Section 2.25, As Found and Cleaned.]

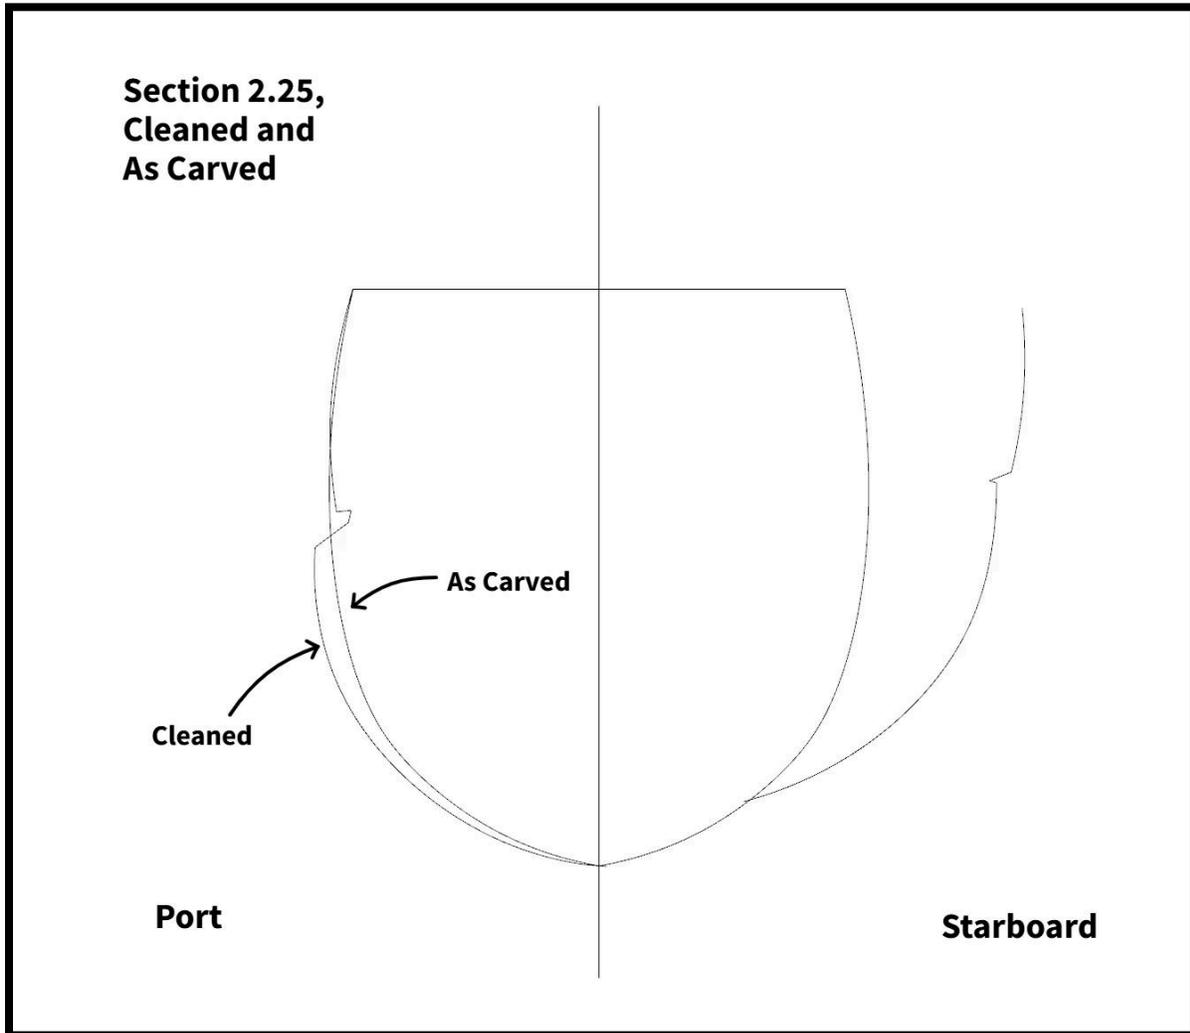
1. Since it appears that the port side has sprung outboard below the split rather than above the split, the lower portion of the curve has been brought inboard and aligned with the curved portion above.

[Figure 34. Section 2.25, Cleaned and As Carved.]
