Study of the Shape of the Historic Skowl Arm Haida Canoe

By V. Jason Rucker and the Haida Canoe Revitalization Group, 2025.

The objective of this report is to explain the modeling and drawing of this canoe clearly enough for others to understand, and to allow them to judge where alternative assumptions or interpretations could be made.

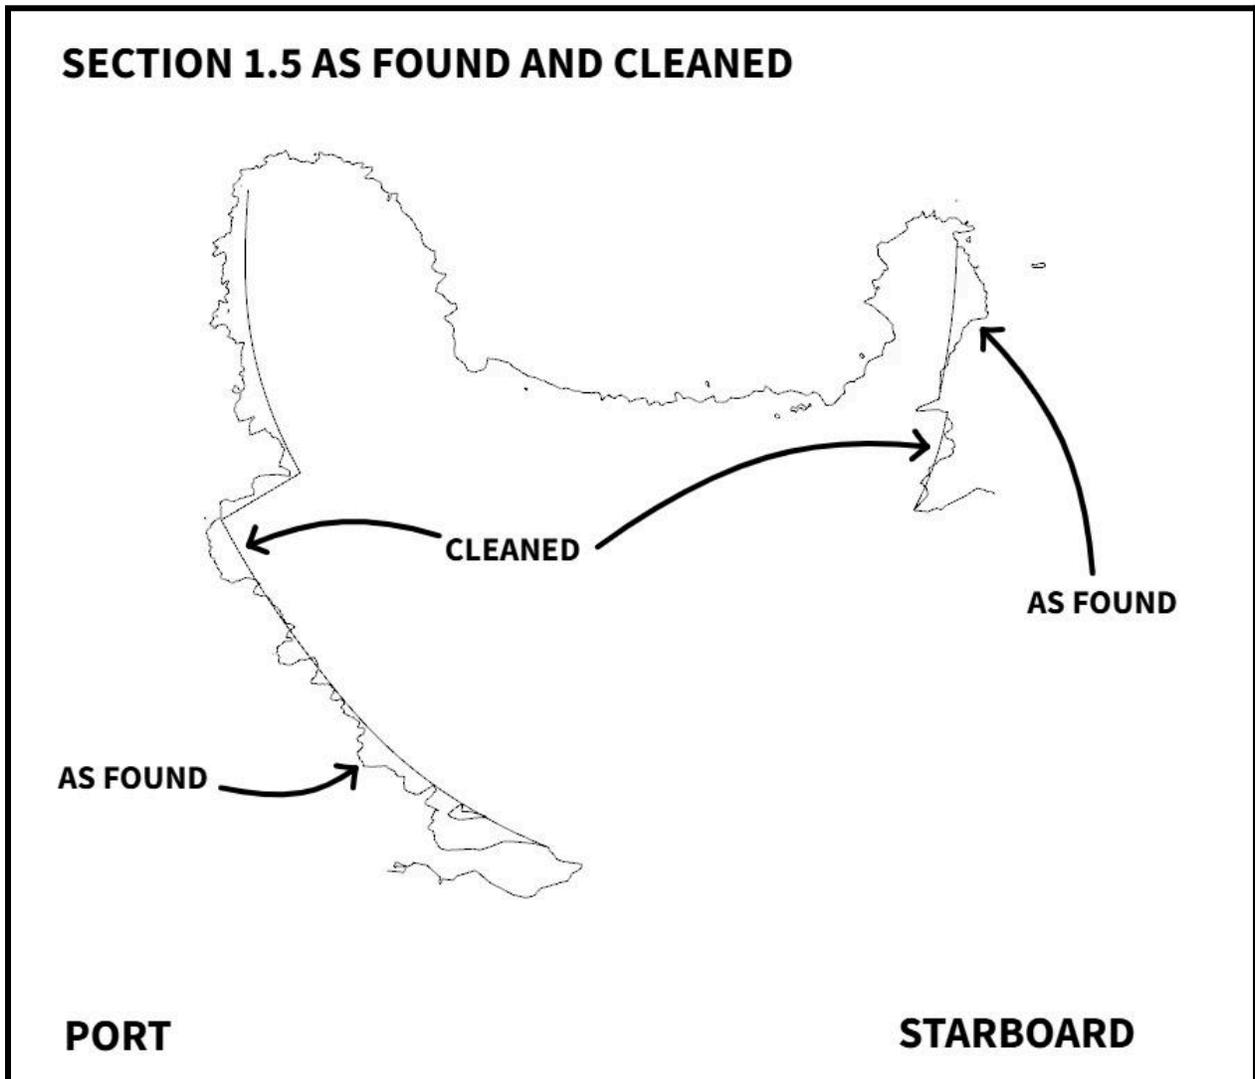
1. In section 1.5, the split in the port side results in the lower portion springing outboard as in section 2.25, only more dramatically. This section shows more of the transition from the round midship sections to the hollowed end of the canoe. The port side has been carved to more of a “V” shape.

[Figure 35. Section 1.5, As Found and Cleaned.]

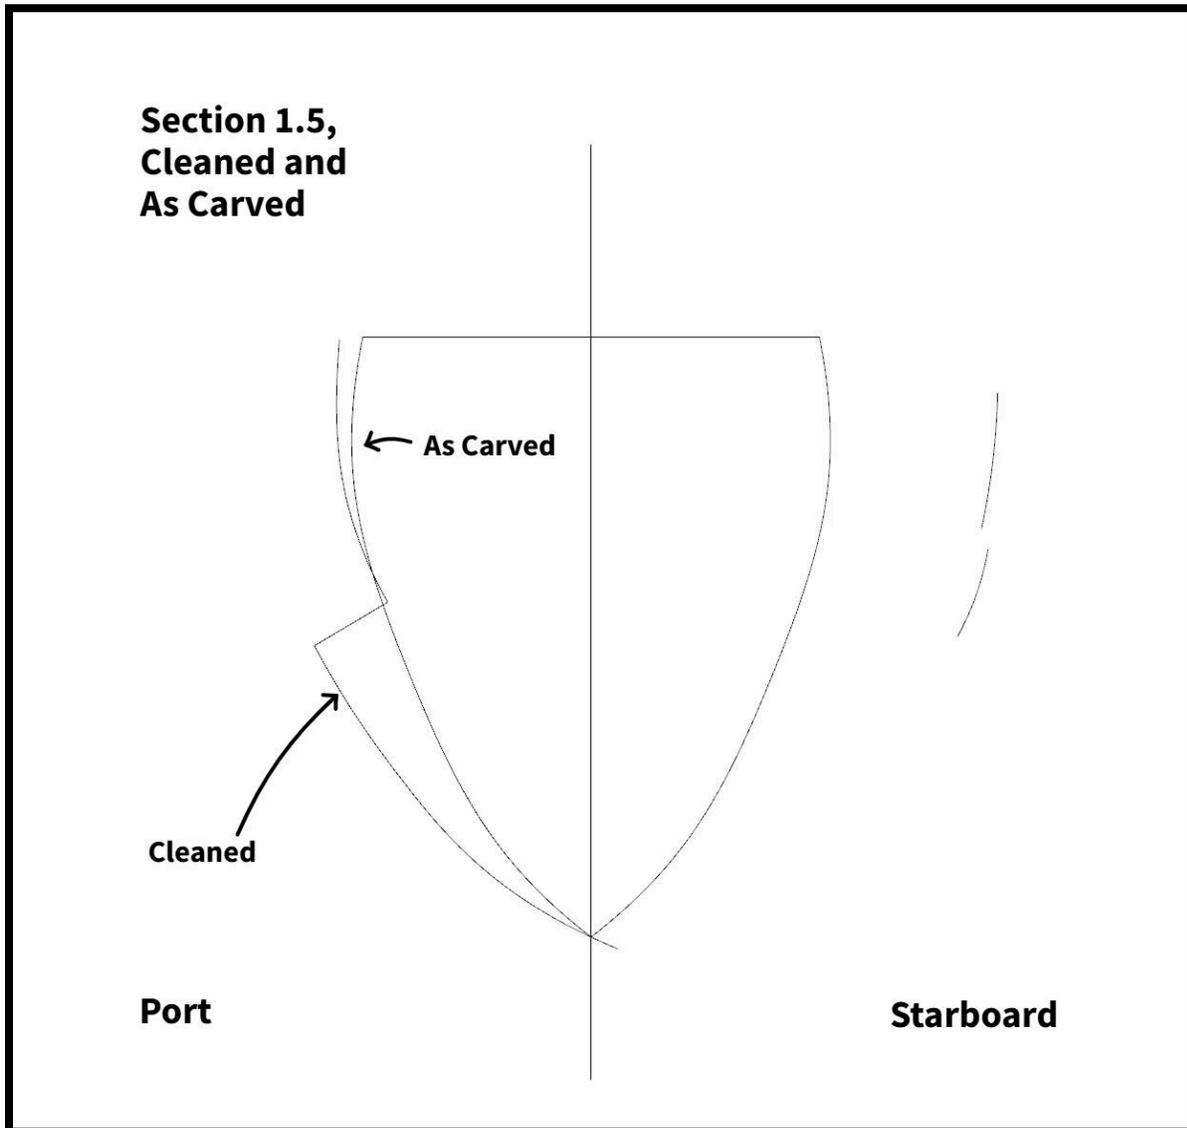
[Figure 36. Section 1.5, Cleaned and As Carved.]

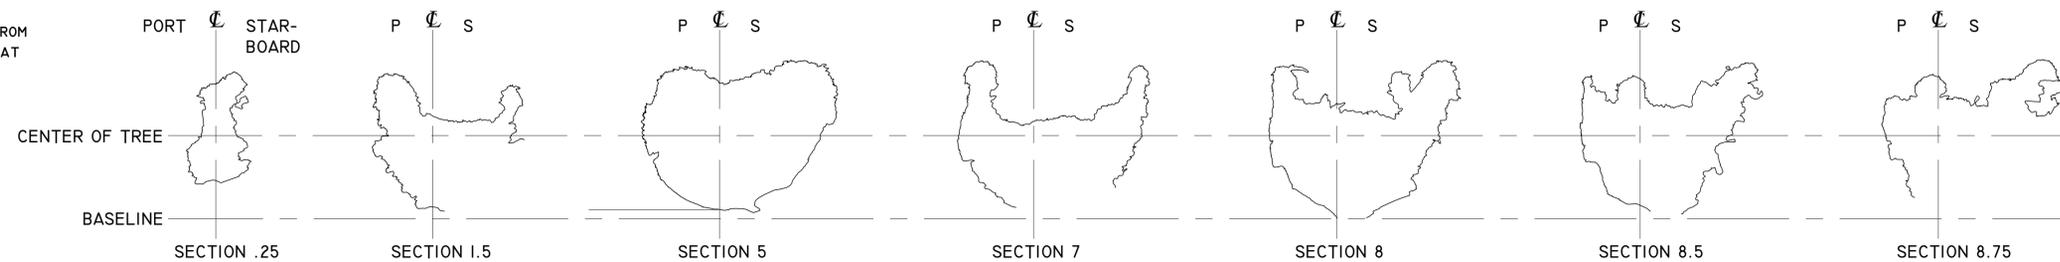
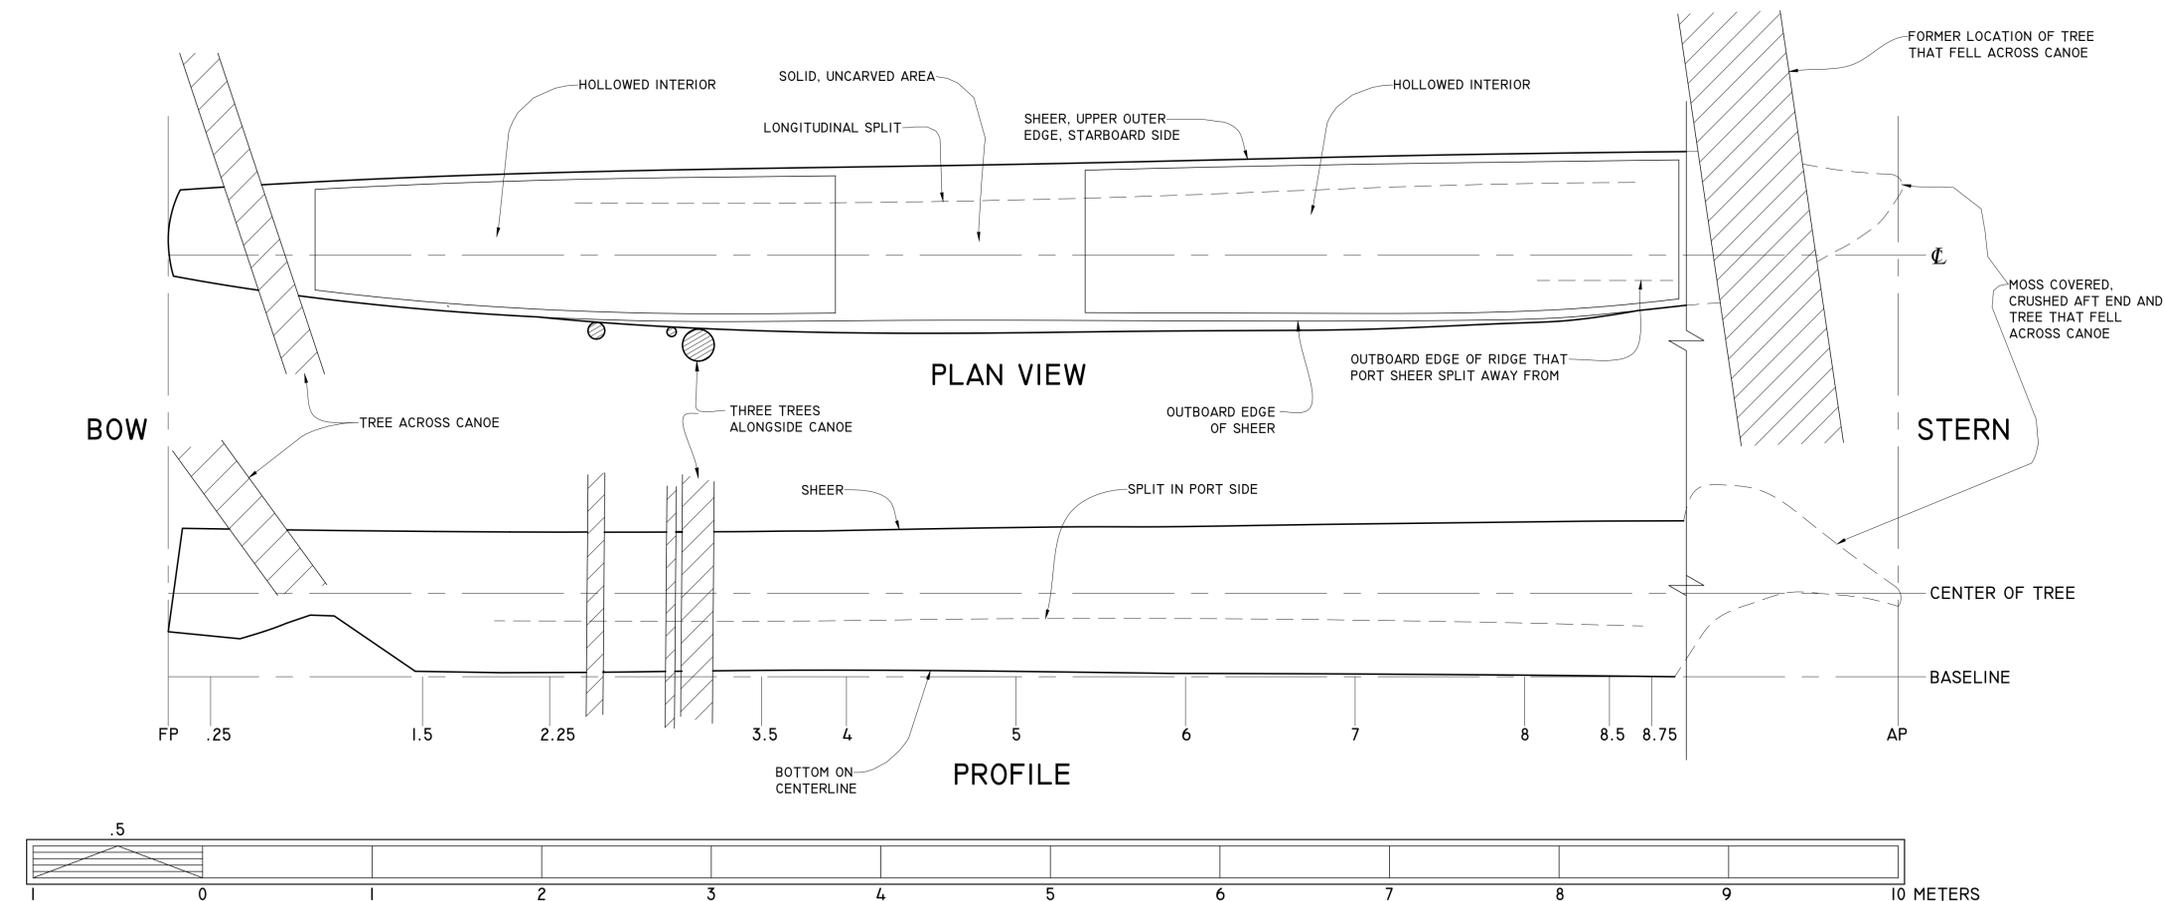
SELECT BODY PLAN SECTIONS

- THE DRAWINGS ON THIS SHEET ARE MEANT AS AN INTRODUCTION TO THE OVERALL SHAPE OF THE CANOE AND ARE REFERRED TO AS THE "AS FOUND DRAWINGS". THE PROFILE AND PLAN VIEWS ARE SKETCHES DRAWN TO SCALE FROM THE 3D COMPUTER MODEL OF THE CANOE. THE BODYPLAN SECTIONS ARE SECTIONS PERPENDICULAR TO THE LENGTH OF THE CANOE. THEY ARE NUMBERED WITH THEIR DISTANCE IN METERS AFT OF THE FORWARD PERPENDICULAR (FP) AT THE BOW. THESE SECTIONS INCLUDE THE MOSS AND TREE ROOTS GROWING ON THE CANOE.

- A VARIETY OF DAMAGE TO THE CANOE IS SHOWN. NOTE THE LONGITUDINAL SPLIT ON THE STARBOARD SIDE IN PLAN VIEW. OUTBOARD OF THIS SPLIT THE WHOLE STARBOARD SIDE HAS TILTED OUT AWAY FROM THE REST OF THE CANOE. IN PROFILE VIEW, NOTE THE LONGITUDINAL SPLIT ALONG THE PORT SIDE OF THE CANOE. FROM THE STERN TO THE TREES ALONGSIDE THE CANOE, THE SIDE IS SPRUNG OUT ABOVE THIS SPLIT. THIS IS MOST DRAMATIC TOWARDS THE STERN AND LESSENS TOWARDS THE BOW. AT BOTH ENDS, TREES HAVE FALLEN ACROSS THE CANOE, BREAKING IT AND ACCELERATING ITS DETERIORATION. ALL OF THIS DAMAGE IS DISCUSSED FURTHER ON SHEET 2.

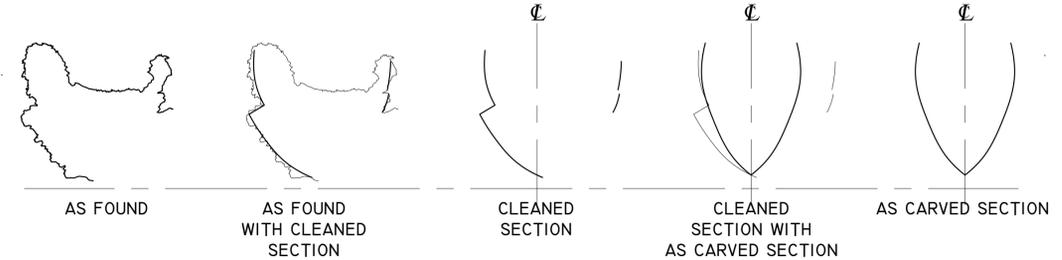
SECTION 1.5

- IN SECTION 1.5, AS IN SECTION .25 THE SPLIT ALSO CAUSES THE LOWER PORTION OF THE CANOE TO SPRING OUT.

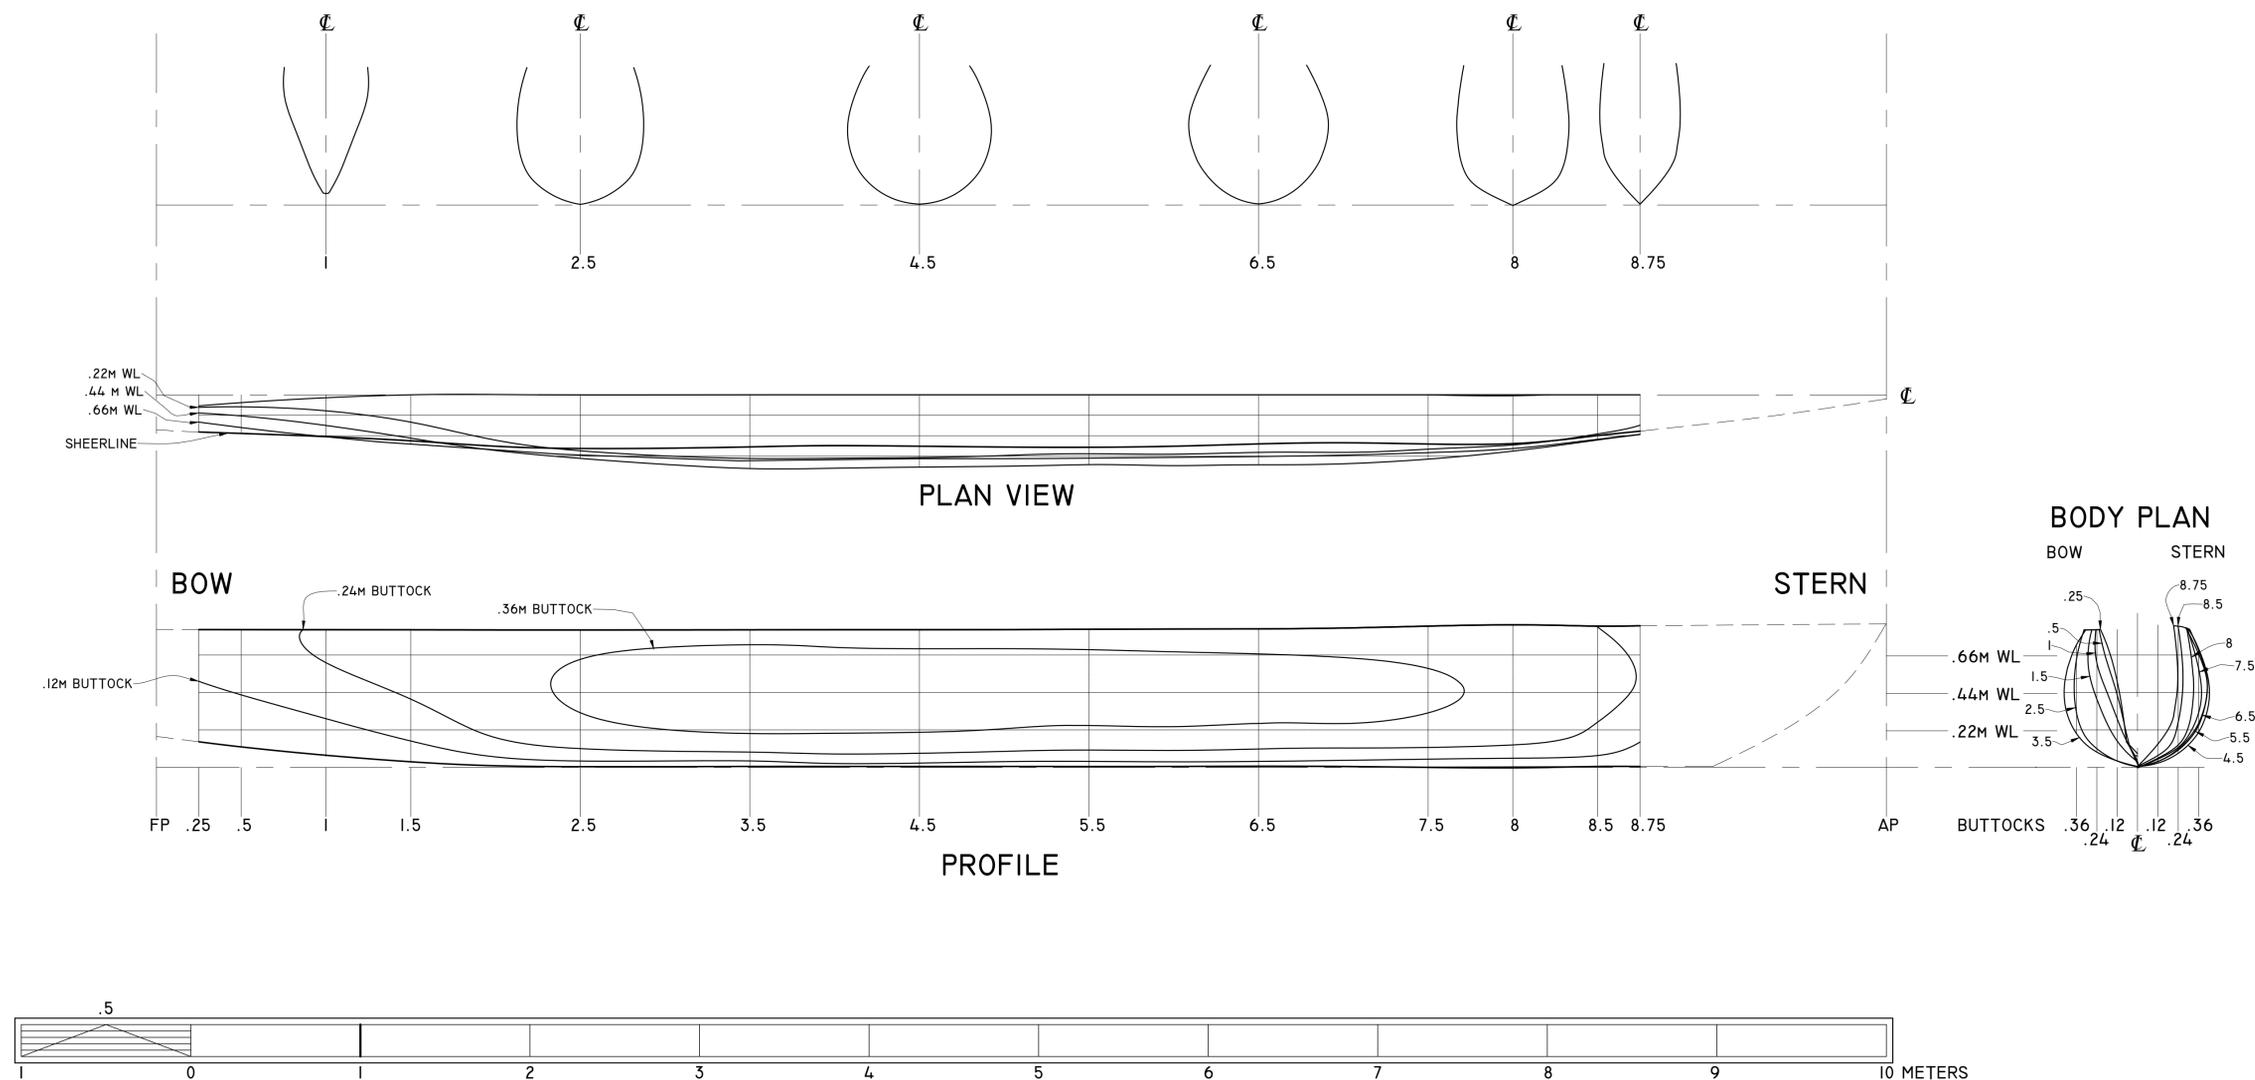
FULL SECTIONS BASED ON THE RECONSTRUCTION OF THE PORT SIDE OF THE CANOE

- THE ENDS OF THE CANOE ARE OUTLINED WITH A DASHED LINE IN THE PLAN AND PROFILE VIEWS. THE AFT-MOST 1.45 METERS WAS TOO DETERIORATED TO RECONSTRUCT. IT WAS IMPOSSIBLE TO SEE THE SHAPE ENOUGH TO MAKE A MODEL OR A DRAWING. SIMILARLY, THE FORWARD-MOST .25 METERS WAS NOT MODELED OR DRAWN. THE DASHED LINES SUGGEST A POSSIBLE SHAPE FOR REFERENCE.

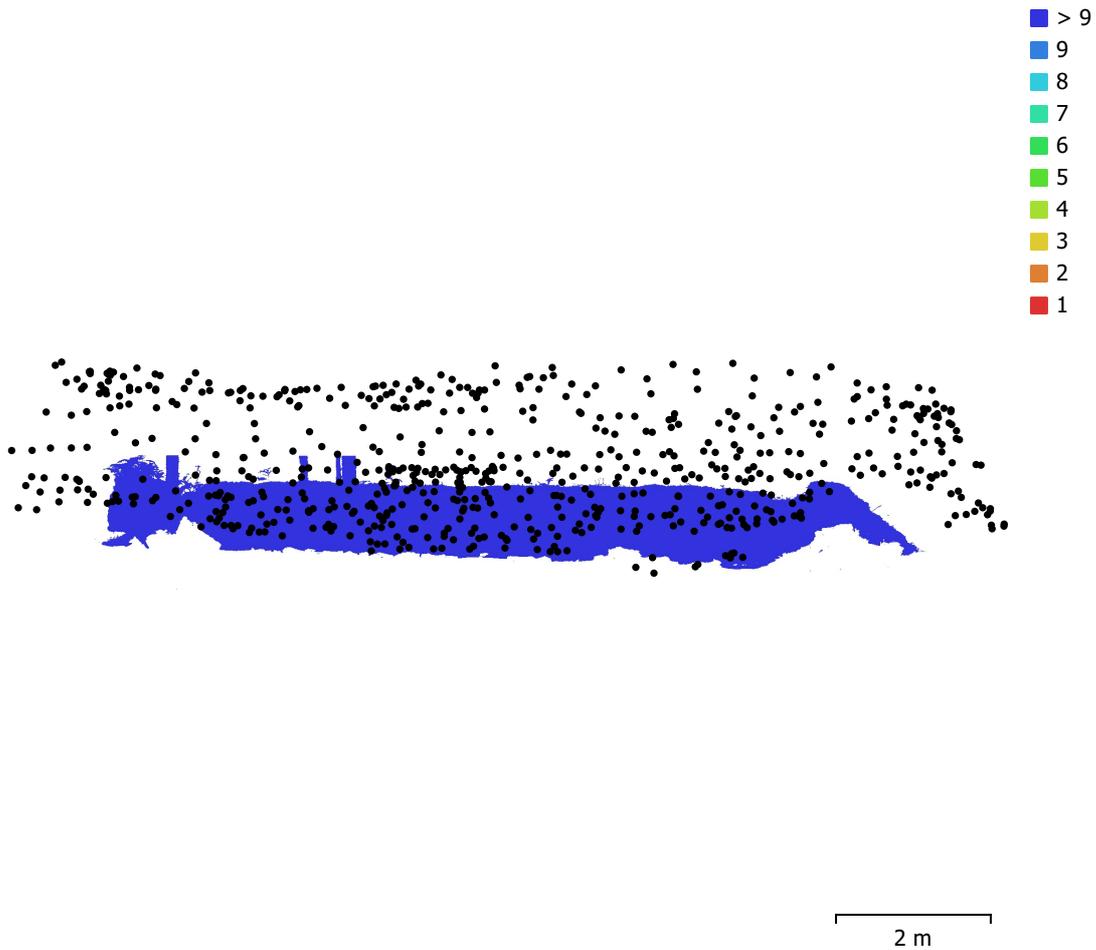
Fig. 1. Camera locations and image overlap.

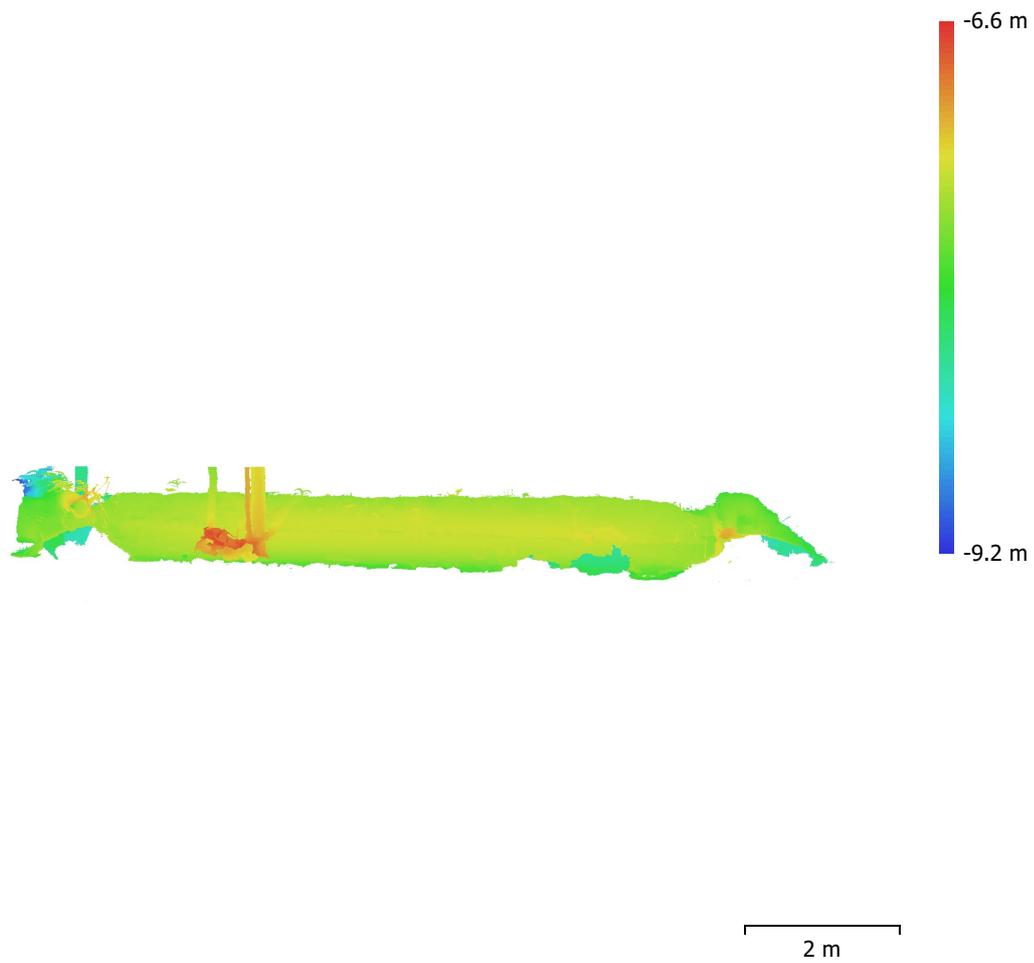
Fig. 6. Reconstructed digital elevation model.

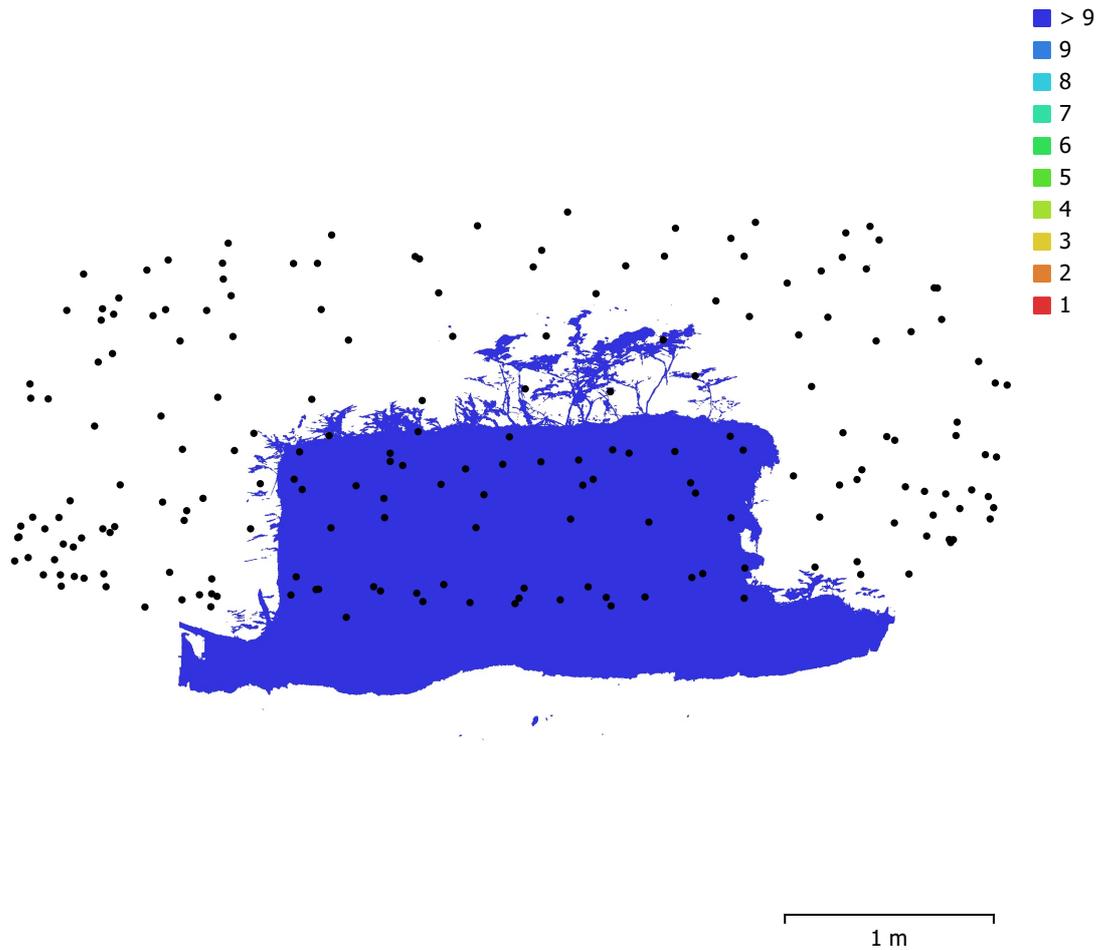
Fig. 1. Camera locations and image overlap.

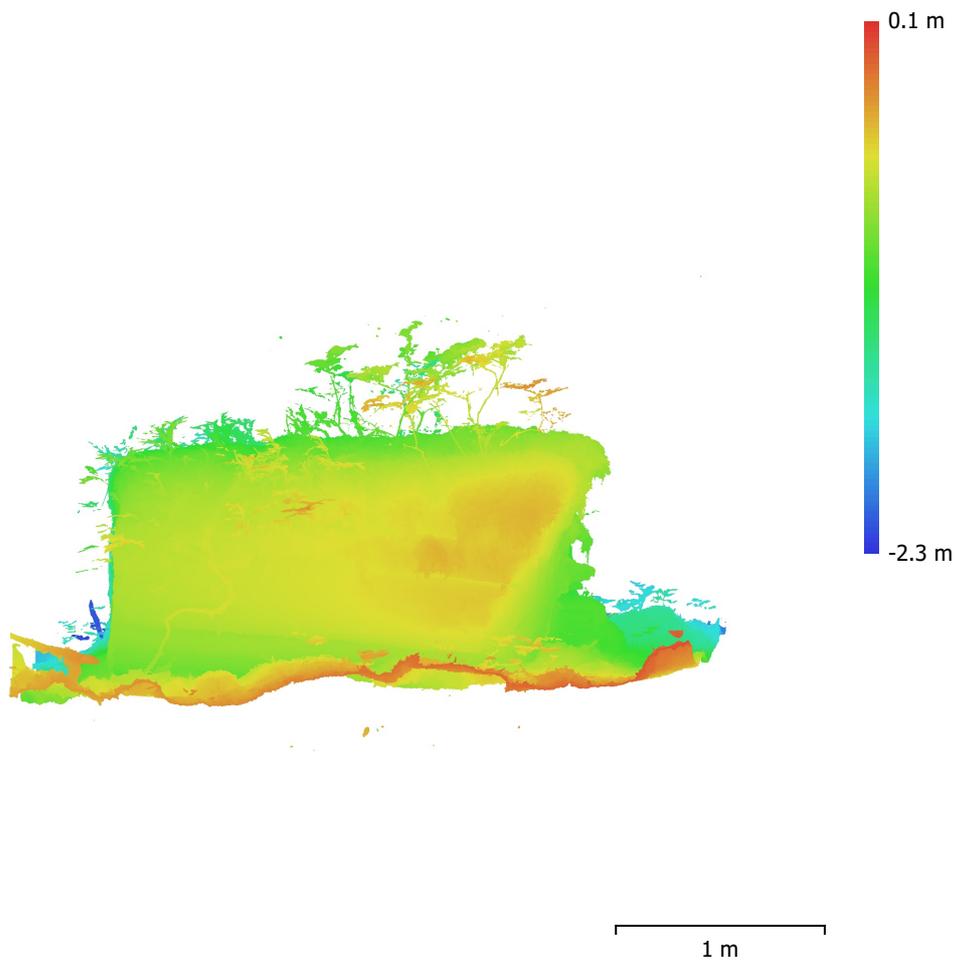
Fig. 3. Reconstructed digital elevation model.

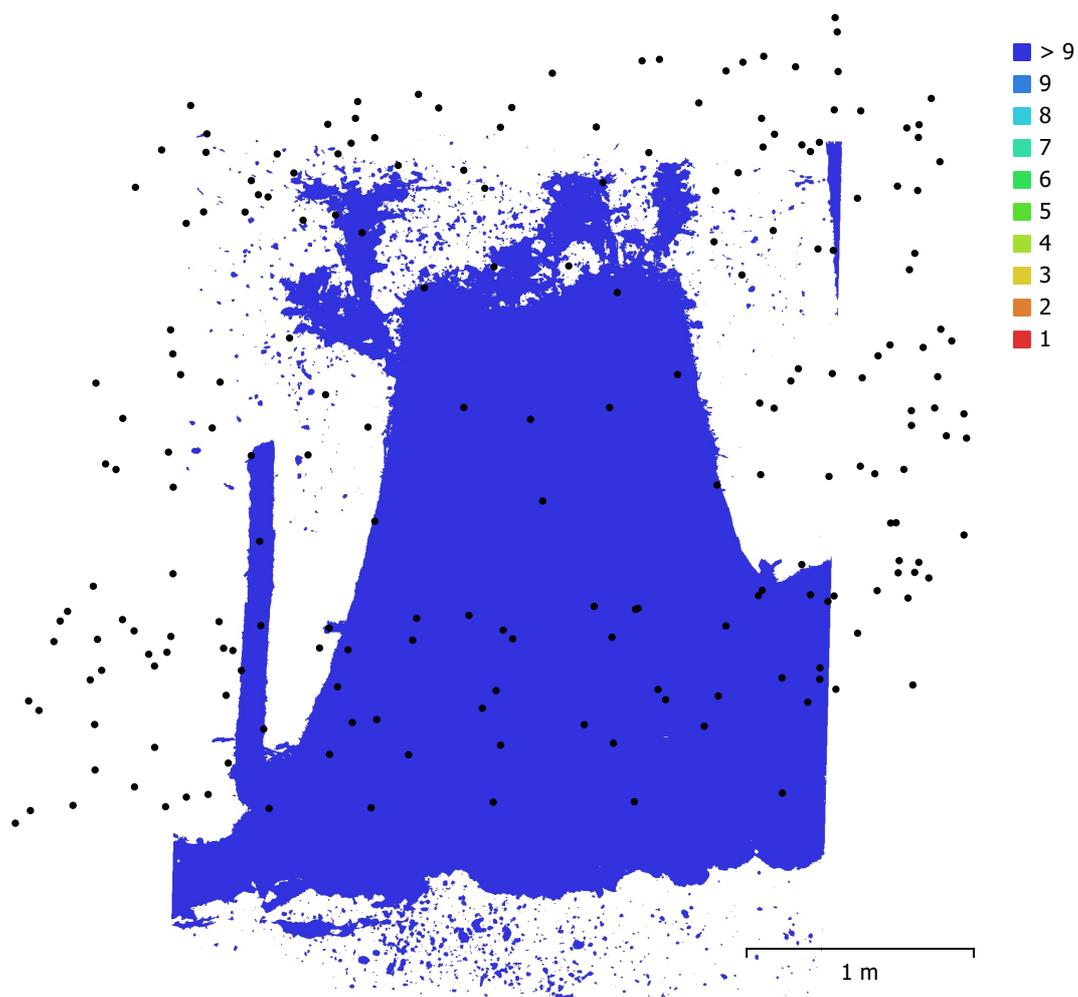
Fig. 1. Camera locations and image overlap.

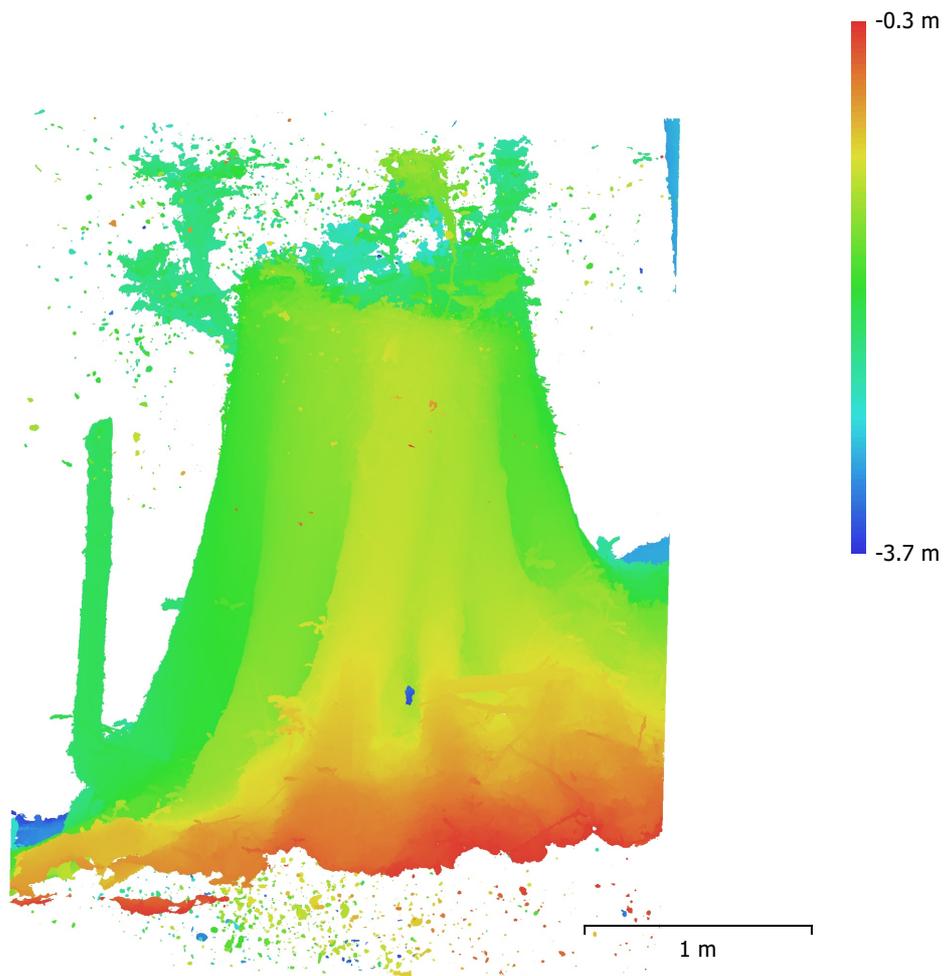
Fig. 3. Reconstructed digital elevation model.
